## **SCHEMATIC DESIGN REPORT**

**RAMSHORN POND DAM**  
**MA00145 / 3-14-186-21**  
**MILLBURY, MASSACHUSETTS**

**PARE PROJECT NO. 13072.00**

**November 2013**

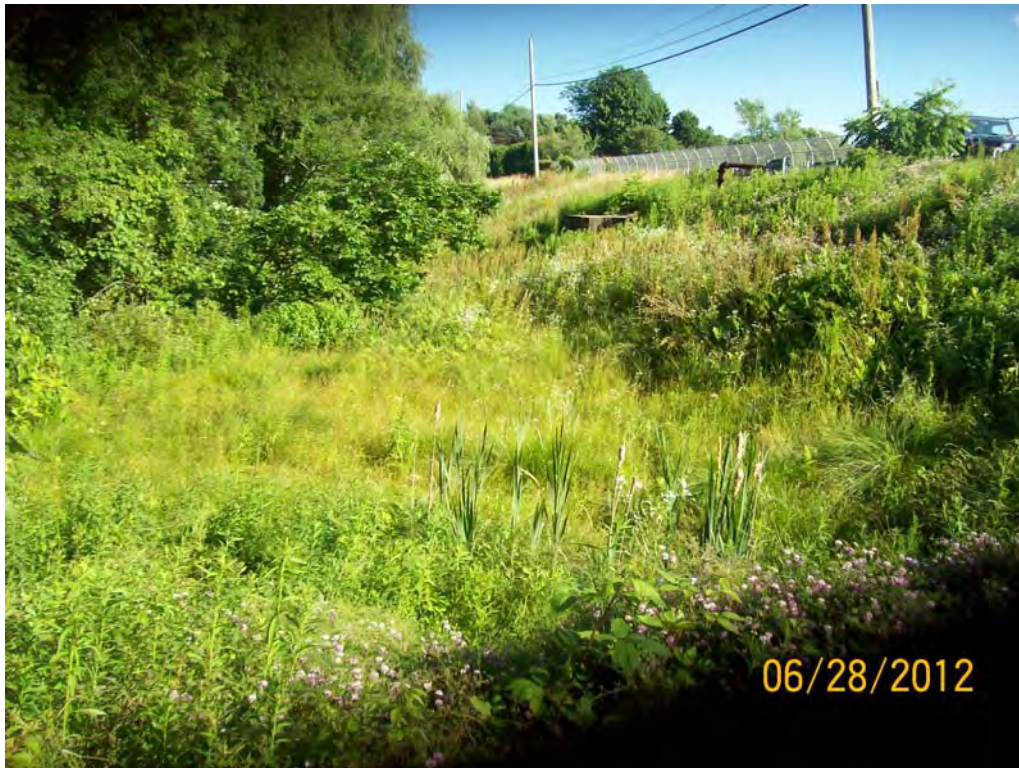
Photo 3 – Downstream slope from spillway channel. Note wetland vegetation at toe of slope due to seepage

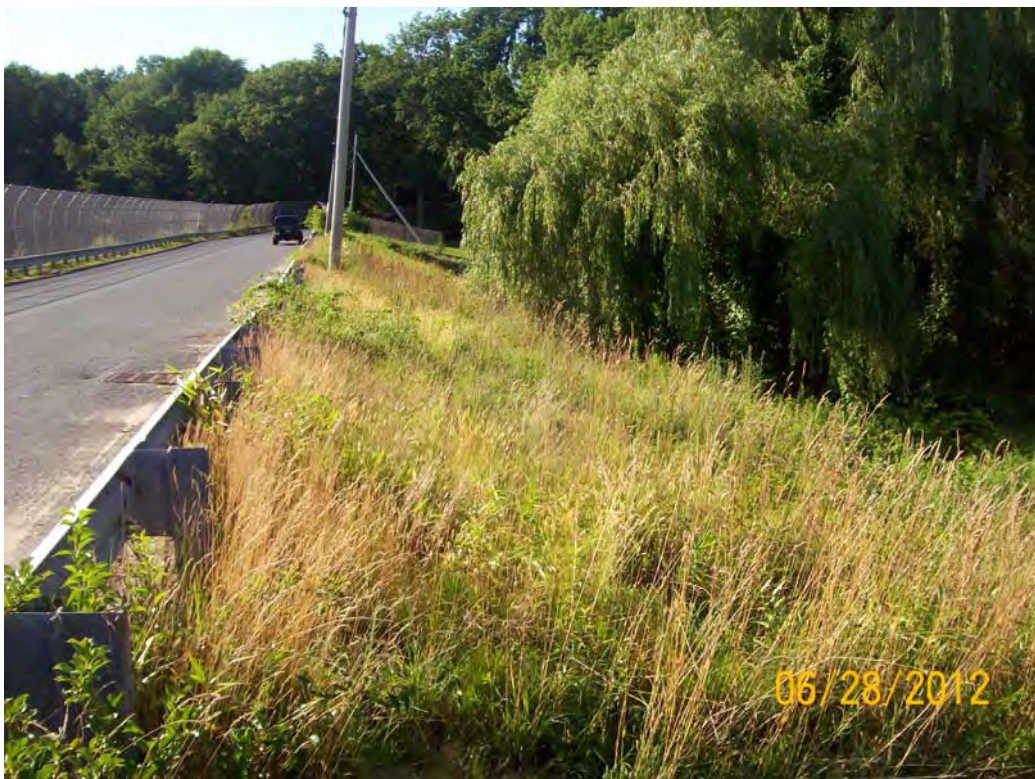
Photo 4 – Downstream slope from right abutment. Note heavy grass growth and large willow tree

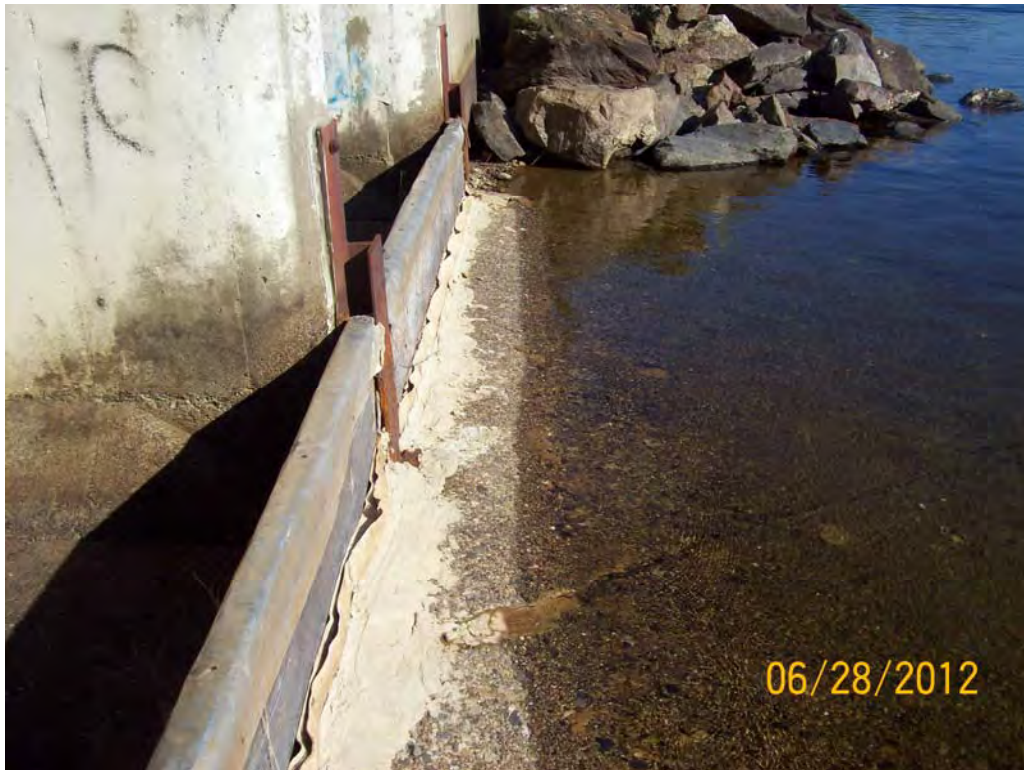
Photo 5 – Spillway flashboards and concrete approach slab.

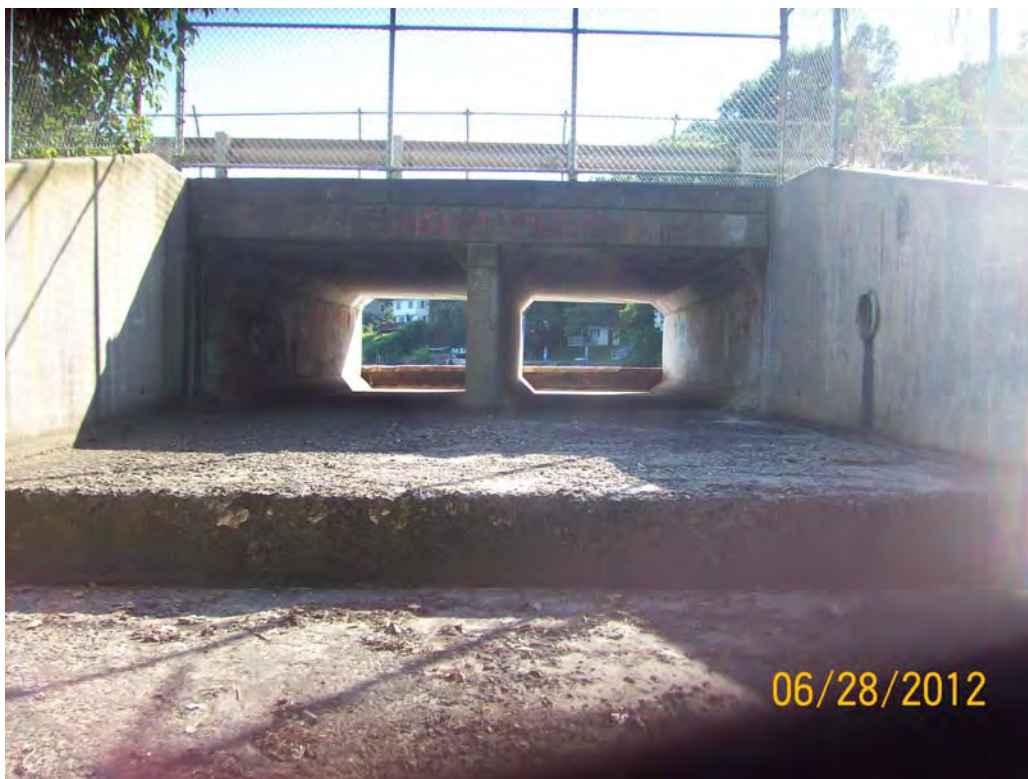
Photo 6 – Looking upstream at twin box culvert spillway. Note flashboards at upstream end
