Town of Millbury Accessibility Plan

***Town of Millbury Accessibility Plan
November 2006***

***Prepared by: James M. Mazik, AICP
Consulting Services
P.O. Box 333 – 130 Ruggles Hill Road
Hardwick, Massachusetts 01037
(413) 477-0914 – (413) 265-9454
jmazik14@comcast.net***

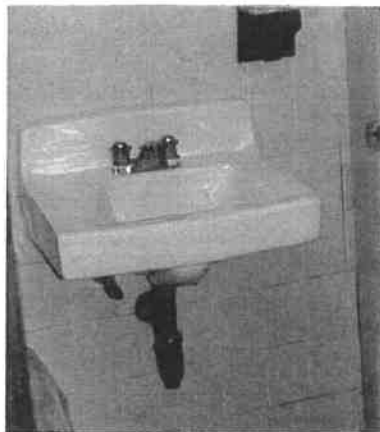
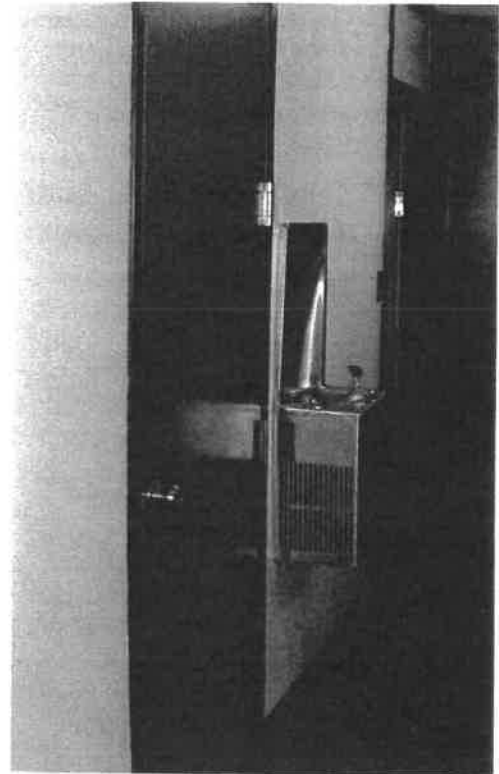
7.	<i>The existing men's and women's holding cells do not meet detention facility standards for accessibility. The minimum 24" door opening is barely achieved; only 32" maneuvering space provided on side of bed (36" min. required); inmate toilets are too low and too close to wall; drinking fountain inaccessible due to location, lack of adequate clear space and approach, inadequate control mechanisms, and lack of knee clearance.</i>		S. 15	<i>Provide at least one fully compliant detention cell. Due to the costs and improbability of modifying the existing cells, a modular cell could be erected in an adjoining area within the station, provided it is on an accessible route of travel.</i>	4	4	\$35,000

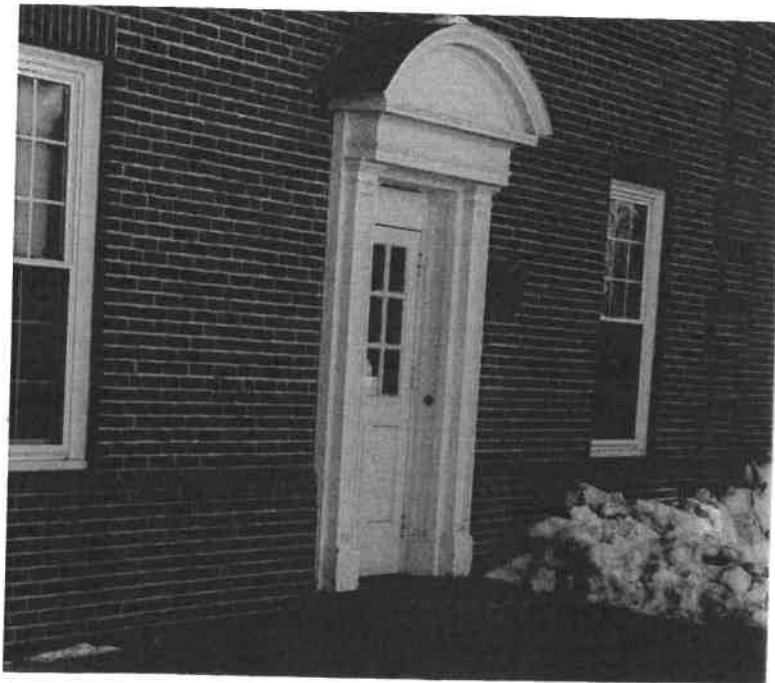
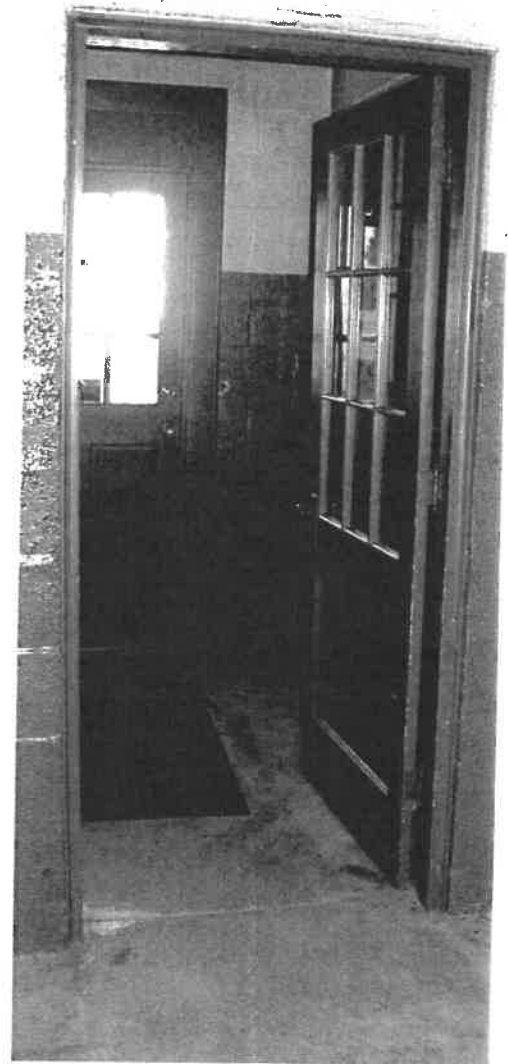
5.	<i>Lack of interior accessible signage to the fire department offices.</i>	S. 4.30	S. 41	<i>Install accessible compliant signage with appropriate finish and contrast and character height and proportions. Raised and Brailled characters should also be included. Signage should be mounted at 60" a.f.f. o.c. adjacent to the latch side of the door.</i>	2	1	\$50

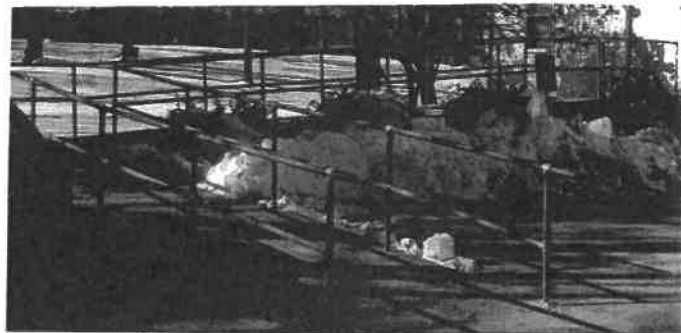
3. <i>The bandstand is wholly noncompliant as there exists no accessible route of travel to the structure and only a set of steps to get inside.</i>	S. 4.3 S. 4.8	S.20 S. 22 S. 24	<i>Construct a 48" wide w/36" clear width accessible pathway to provide access to the bandstand. Construct a ramp into the bandstand which meets all accessibility requirements. This should include the construction of a ramp which does not exceed a running slope of 8.3% nor a 2.0% cross-slope. A 60" x 60" level area at the ramp base and top is required. Four feet of clear space is required between handrails. The handrails shall be continuous on both sides of the ramp, 1-1/4" to 1-1/2" in outside diameter, and round or oval in shape; handrails to be provided in pairs, one at a height of 34" - 38" above the ramp surface and the lower handrail at a height between 18" and 20"; handrails to be 1-1/2" from the mounted surface; handrails should extend 12" beyond the bottom of the ramp.</i>	1	3	\$12,500

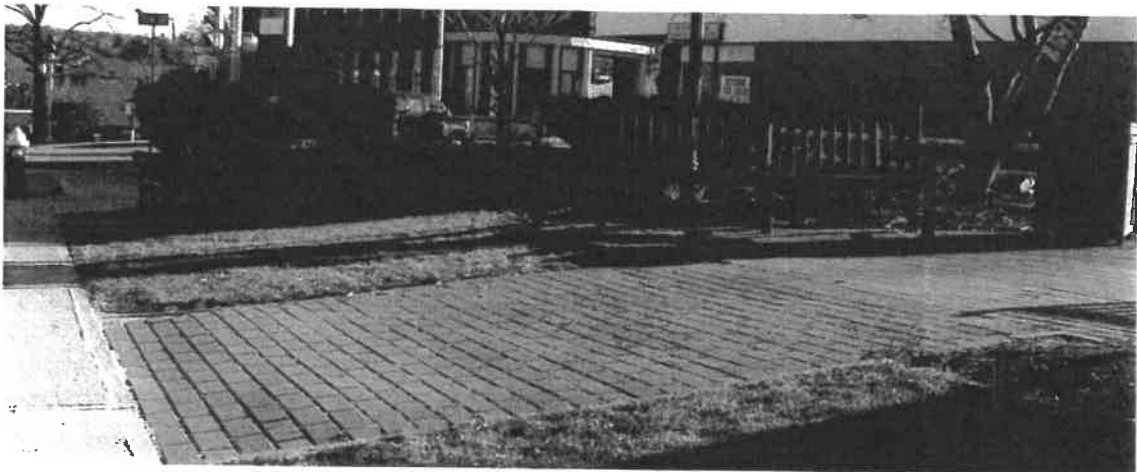
3. <i>No hard packed level surface for a wheelchair sitting area exists adjacent to the bench which is parallel to the sidewalk on Main Street.</i>	S. 4.33	S. 19	<i>Adjacent to the bench, expand the existing brick paved area to include an additional 36" x 60" brick-paved area.</i>	2	3	\$500

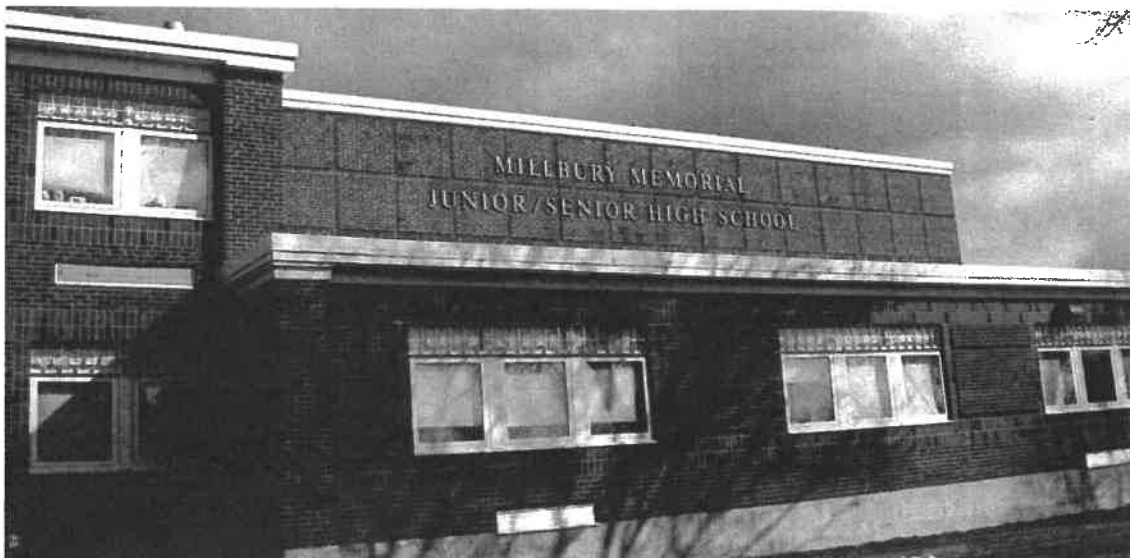
3.	Closing speed of main entrance doors to high school vary from 3 to 5 seconds, exceeding the maximum 6-second closing speed. <i>Action required: Adjust the door closers such that the 6 second minimum closing speed is achieved.</i>	\$75

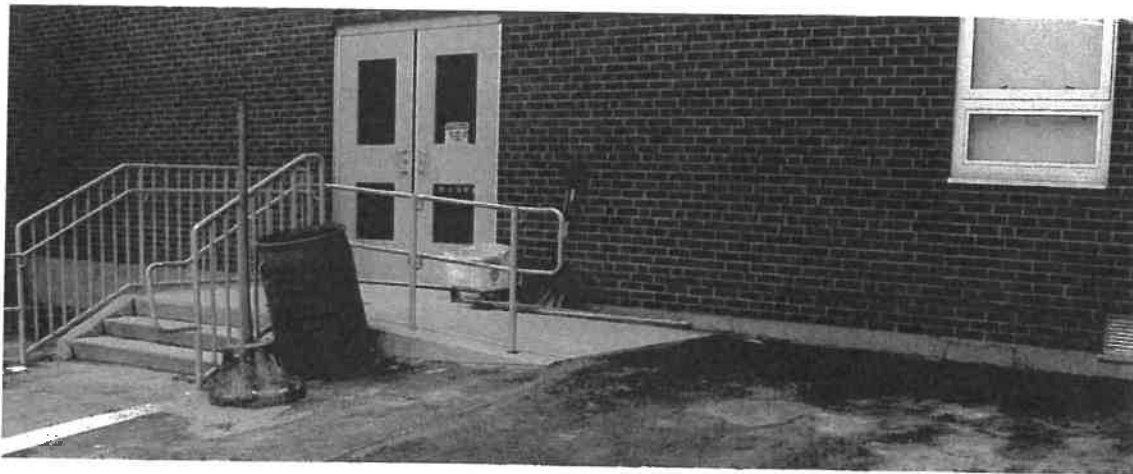
| 3. Closing speed(s) of double-door gym entrance doors vary from 3 to 4 seconds, exceeding the maximum 6-second closing speed. <i>Action required: Adjust the door closers such that the 6 second minimum closing speed is achieved.</i> | \$75 |

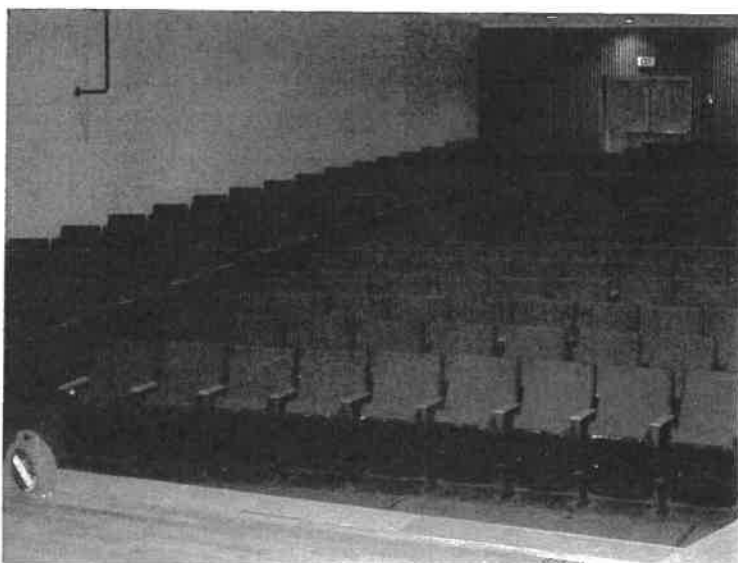
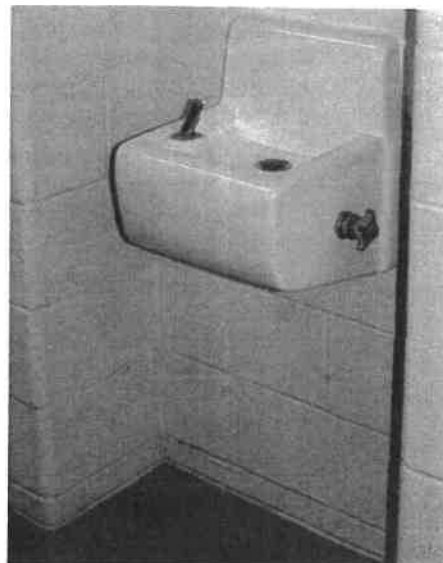
<u>Boy's Locker Room</u>	
1. All lockers fail to meet reach range and clear floor space requirements for wheelchair access. The drinking fountain is wholly non-compliant with a knob-style control, a spout height of more than 36" a.f.f., inadequate knee clearance and insufficient clear width space. Urinal does not have a minimum of 29" clear width space due to cross support of urinal shield. Shower wholly non-compliant due to a 5½" vertical obstruction into showers and lack of compliant shower controls. <i>Action required: Provide at least two accessible lockers meeting reach, turning radius and clear floor space thresholds. Remove urinal shield or replace with a new shield which allows for the minimum 29" clearance. Install new high/low accessible compliant drinking fountain with maximum spout height of 36" a.f.f. for low and 43" a.f.f. for high fountain. Construct wing or flange wall on side(s) of drinking fountain to minimize protrusion to a maximum of 4". Modify existing shower by removing 5 ½" berm into shower area and installing at least one compliant shower fixture and related hardware.</i>	\$5,950

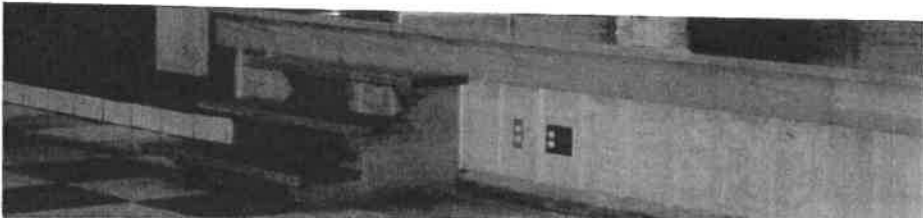
<u>Gym Area - Girl's Locker Room</u>	
<p>1. Access to the girl's locker room is non-compliant with knob-style door hardware and a push/pull force of 8 lbs. All lockers fail to meet reach range, clear width and clear floor space requirements for wheelchair access. Similarly, the showers are wholly non-compliant including a restricted access due to a 23" clear width space to and a 36" x 36" turning area within the shower. The drinking fountain is wholly non-compliant with a knob-style control, a spout height of more than 36" a.f.f., inadequate knee clearance and a protrusion of more than 5" into the accessible route of travel. The water closet stalls, water closet, sinks and dispensers are non-compliant, lack accessible features and exceed height and reach range standards. <u>Action required:</u> Replace door hardware with a lever or other appropriate and compliant hardware. Adjust door closer to comply with maximum 5 lbs. push/pull force requirement. Provide at least two accessible lockers and showers which meet reach, turning radius, clear floor space thresholds and fixture and hardware requirements. Install a new accessible compliant drinking fountain with maximum spout height of 36" a.f.f. Install at least one fully compliant water closet, sink, and related fixtures and dispensers.</p>	\$25,200

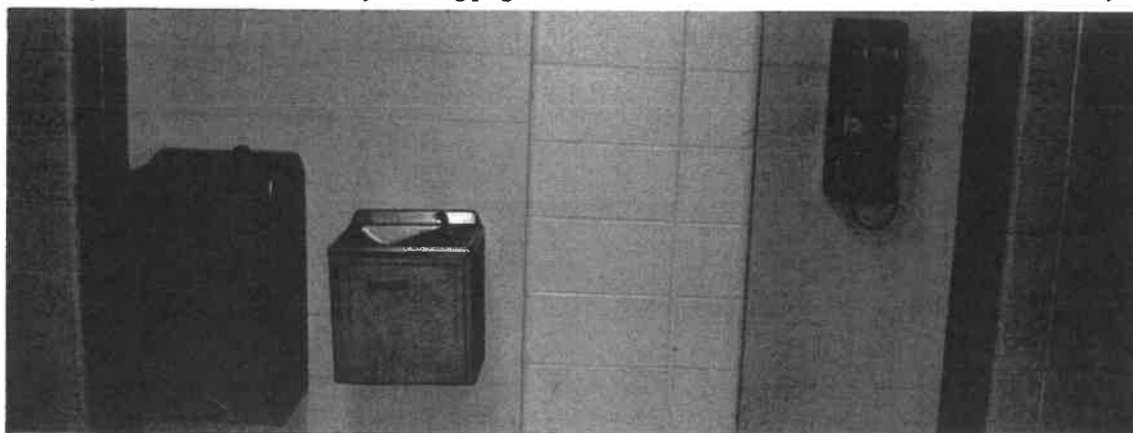
1. The chart on the following page summarizes the various area of non-compliance in the bathrooms of the building. Ten bathrooms were assessed. Of these, two were designated as "handicapped accessible", two were men's and women's bathrooms, two were staff bathrooms and four were regular student bathrooms. <u>Action required:</u> Modifications as stated on the following page.	\$95,000

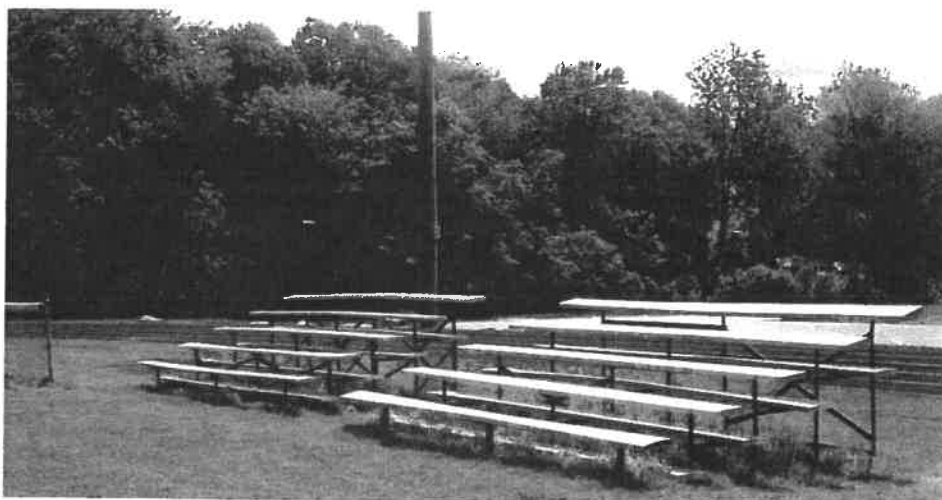
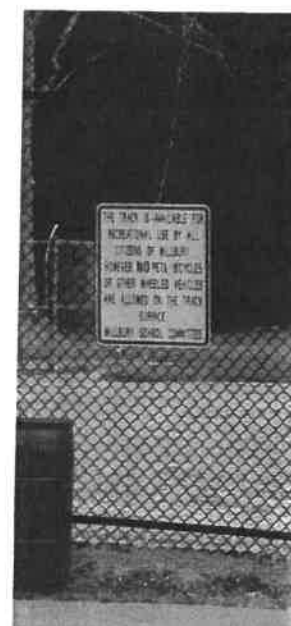
4. Lack of railings in bleachers.	Install accessible compliant railings.	1	3	\$1,500
5. Lack of "allowable" accessible route of travel around facility.	Modify school committee policy/ruling to allow wheelchair access and use of track.	1	1	\$0
Total				\$5,125

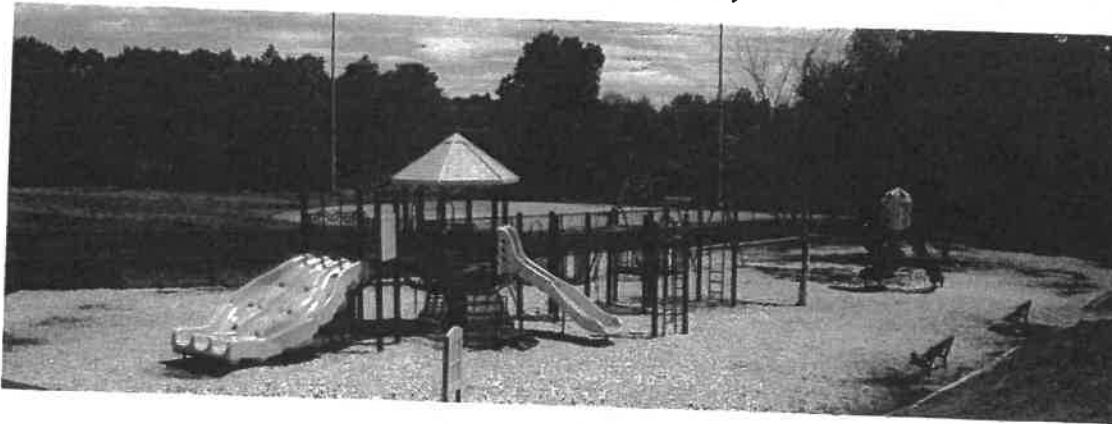
3. No accessible route of travel exists to the side play area, around the play area or to the various play components, including swing sets.	Construct a 48" wide w/36" clear width accessible pathway to and around the play areas. Install a stable, firm and slip-resistant as well as "impact attenuating" surface around and to play equipment. Acceptable materials include interlocking rubber matting, plastic matting, poured in place rubber surfacing and specially bonded wood fibers.	1	3	\$80,000

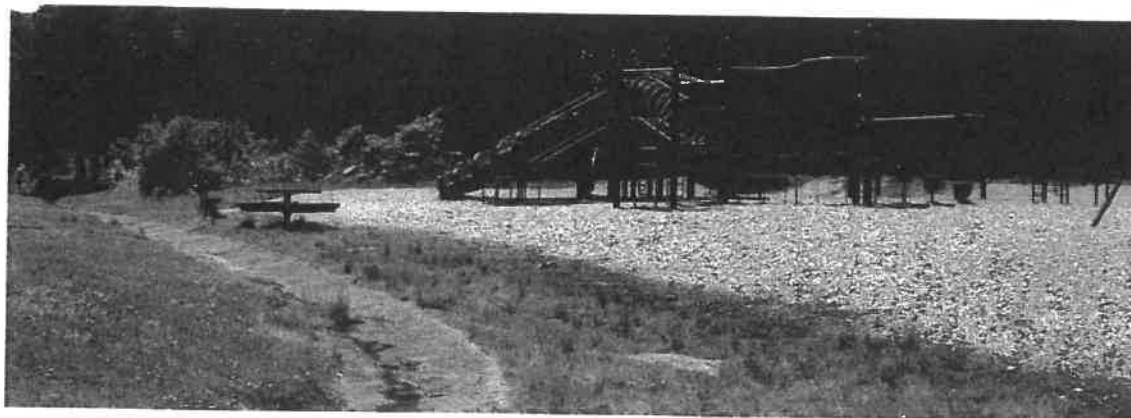
Greenwood Street Park: Neighborhood playground and park consisting of a baseball field, a soccer field, a basketball court, swings, and 2 spring rider play devices. No designated accessible parking exists in the "upper" parking lot. The "lower" lot has two non-compliant striped accessible spaces. An accessible portable toilet is located in the upper parking lot. No accessible routes of travel exist to the ball fields, play components or basketball court. None of the bleachers have railings. Future playground equipment replacement or expansion should comply with the guidance provided in Attachment H.

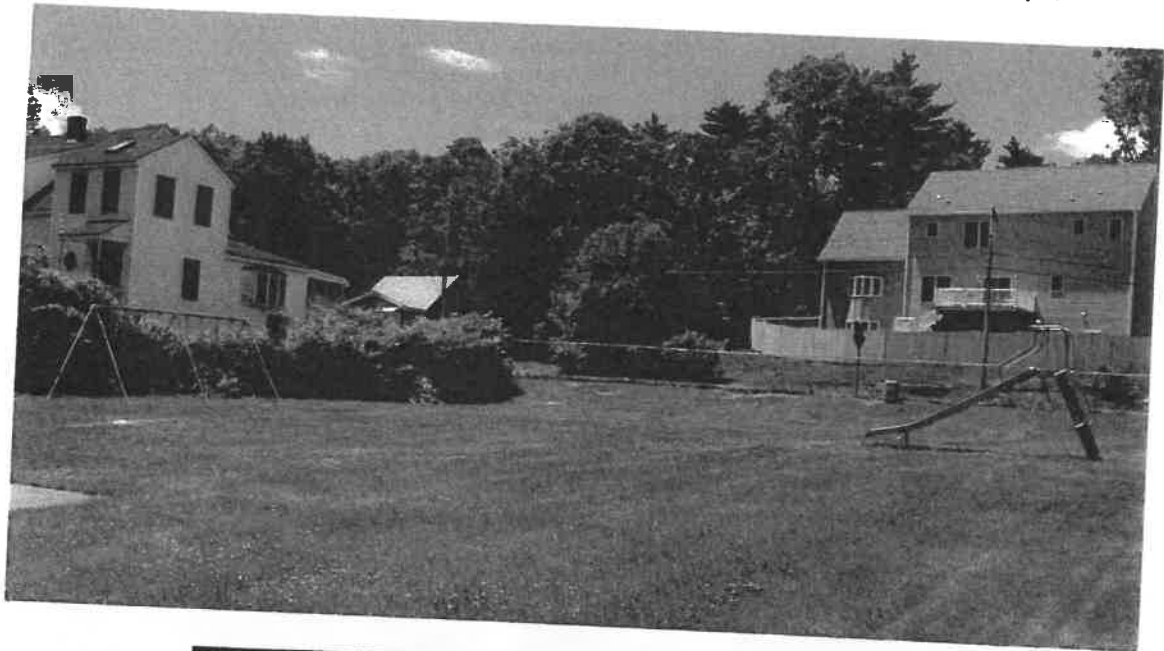
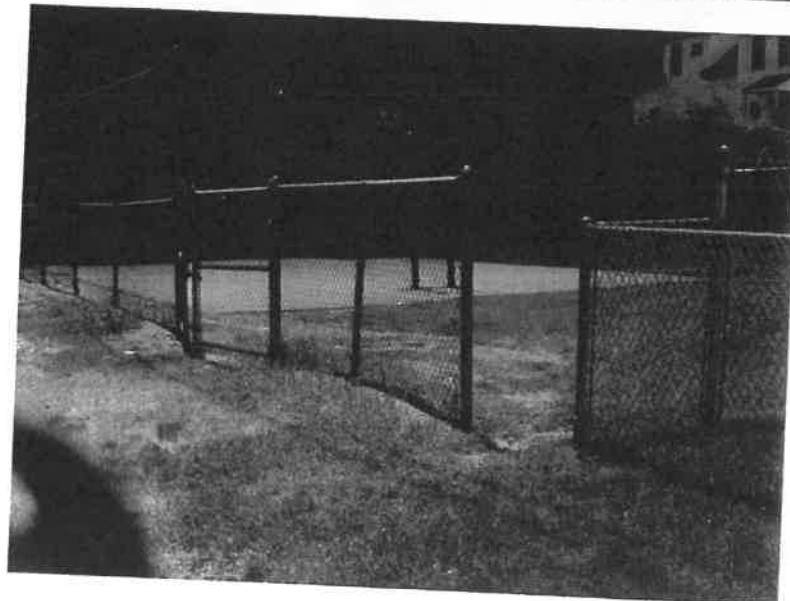
East Millbury Park: Neighborhood playground and park consisting of 2 baseball fields, 2 basketball courts, swings, slides, a carousel and 2 spring rider play components. The parking area is partially improved, with the parking closest to the entrance being an unimproved and unstable surface. An accessible portable toilet is located on the unimproved parking lot next to the main entry. No accessible routes of travel exist to the ball fields, basketball courts or play components. In fact, in some areas, the existing route of travel between fields and play areas consists of a narrow, worn dirt path with exposed rock and tree roots in the pathway. None of the 3 bleachers have railings. Future playground equipment replacement or expansion should comply with the guidance provided in Attachment H.

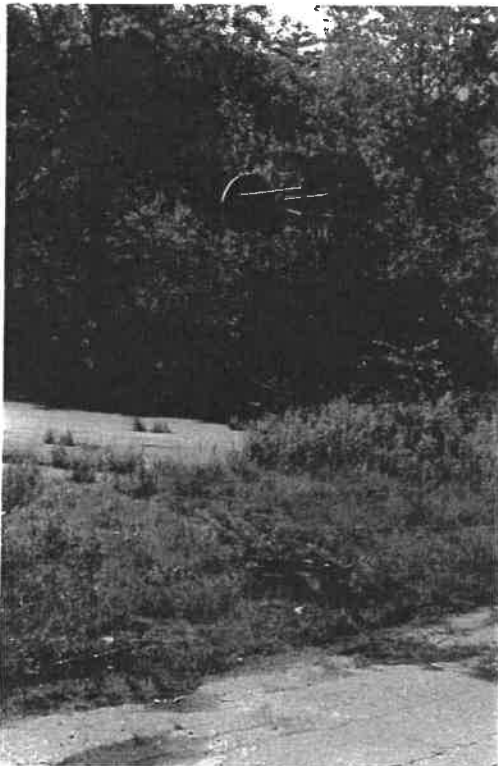
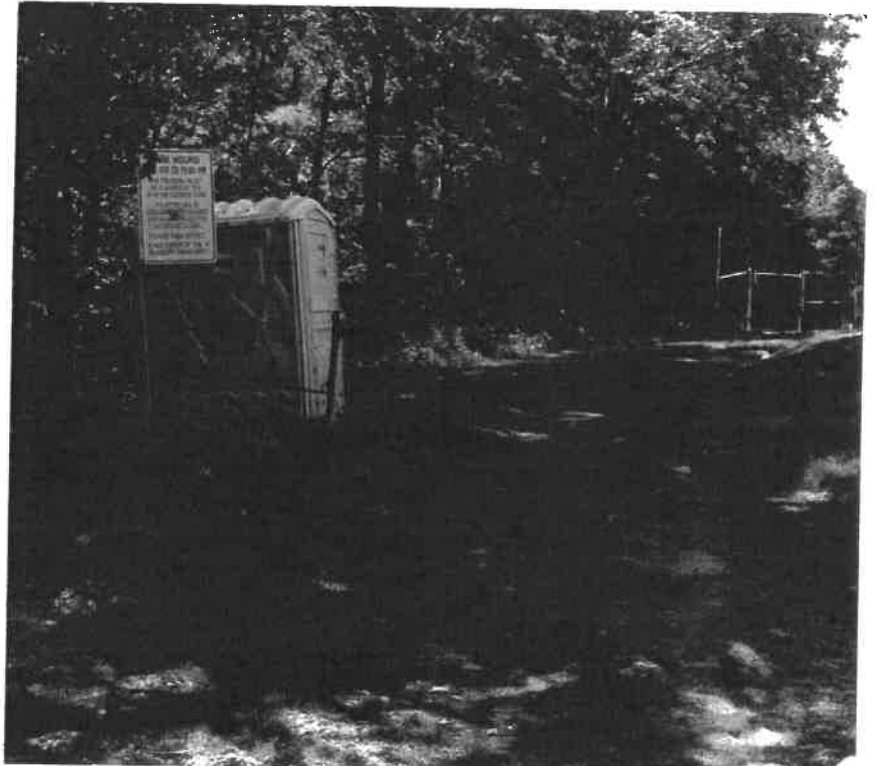
Jacques Park: A rural "neighborhood" park with minimal improvements and in an overall "poor" condition. The park consists of an overgrown and inaccessible basketball court, a baseball field, 6 swings, 2 bleachers and an accessible portable toilet. The basketball court appears to be abandoned due to the extensive overgrowth and condition of the court. In addition, no formal parking exists adjacent to the basketball court. Should the basketball court be put back into use, it will need to be made compliant by creating an accessible route of travel to this facility. The parking for the baseball field and swings is an unimproved and unstable gravel surface and therefore non-compliant. No signage or striping is provided. The "accessible" portable toilet is located on an unimproved and uneven gravel and grassed surface rendering it non-accessible. No accessible route of travel exists to the ball field, bleachers or swings. Railings are not provided on the bleachers. None of the swings are accessible.
