**Town of Millbury
Self-Evaluation and Transition Plan
June 2023**

TOWN OF MILLBURY – SELF-EVALUATION AND TRANSITION PLAN

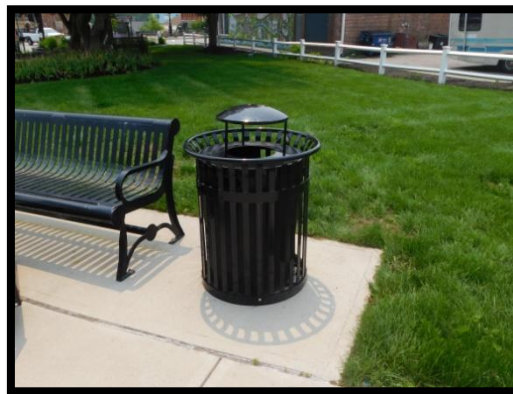
The trash receptacle next to a bench in the Upper Town Common restricts the level area for a wheel chair. It is recommended that the trash receptacle be relocated.

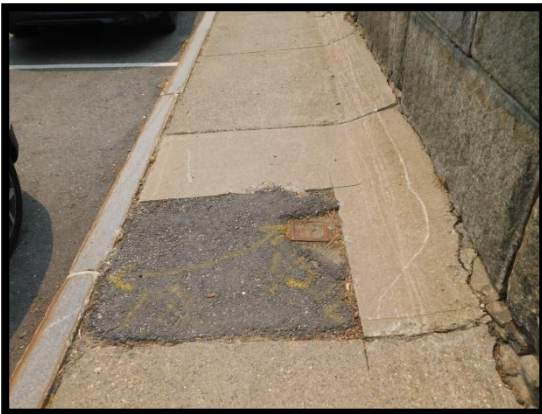
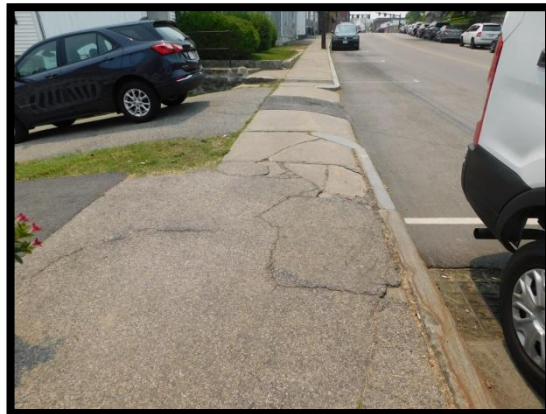
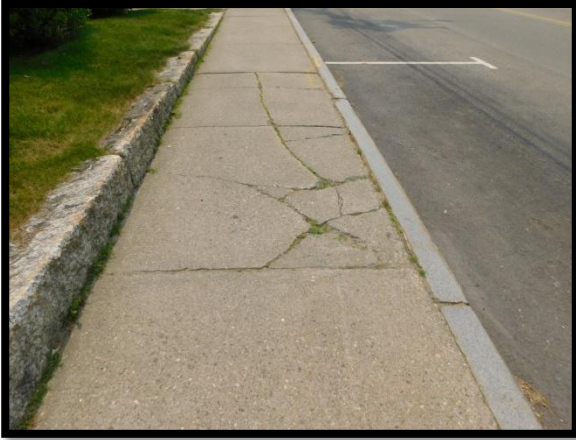
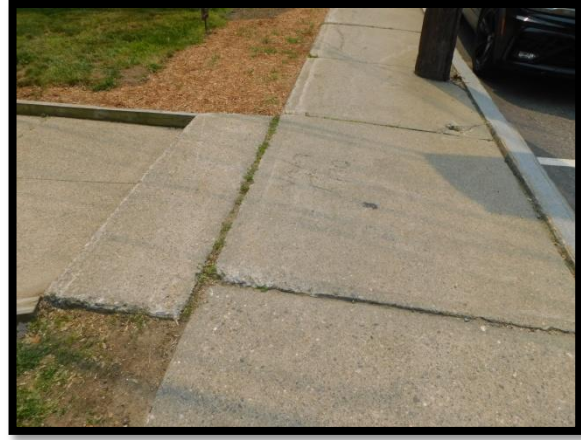
- The sidewalk from #69 to #73 have cross slopes of 3.4% to 6.0%.
- The concrete at #65 is heaving with abrupt changes in level surface.
- A concrete pad at #81 has an abrupt change in level surface of up to 1½”.
- The sidewalk at the #53 and Mykonos Bakery has sidewalk deterioration, an abrupt change in level surface of 1+”, and cross slopes of up to 14.0%.
- The sidewalk at #55 has deterioration, abrupt changes in level surface, and heaving concrete.
- The sidewalk at #82 has cross slopes of 4.8% to 6.8% with abrupt changes in level surface (gas cover)

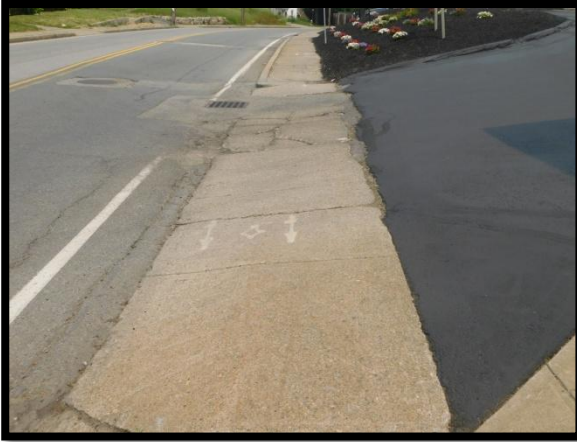
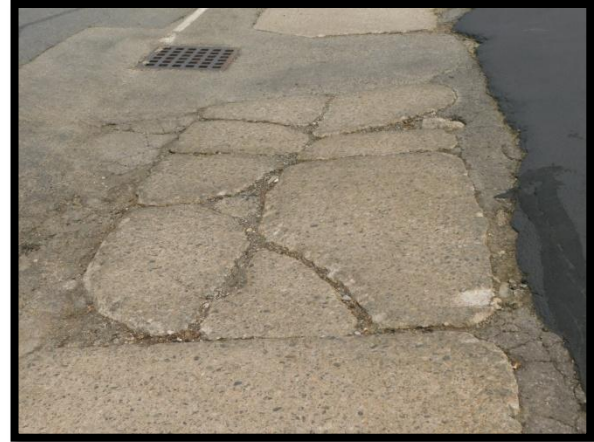
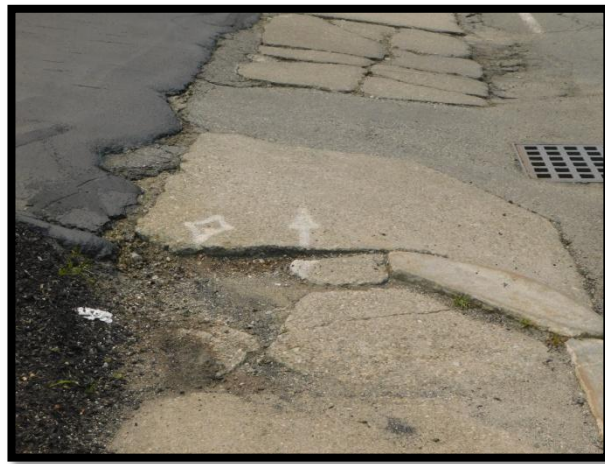
- The sidewalk from #26 to #34 has cross slopes of 5.8% to 9.4%. The clear width is reduced to 23" due to outside seating tables and chairs.
- The sidewalk at #36A to Ray's Barber Shop has cross slopes of 6.0% to 6.4%.
- The sidewalk/driveway at Ray's Barber Shop and the Millbury Credit Union has cross slopes up to 6.4%.
- The Millbury Credit Union sidewalk/driveway on Main Street has cross slopes of 3.8% to 6.2%.
- The Millbury Credit Union sidewalk/driveway on Canal Street has severe deterioration with up to 6" gaps, heaving, up to 3" abrupt changes in level surface, and cross slopes of up to 15.0%.

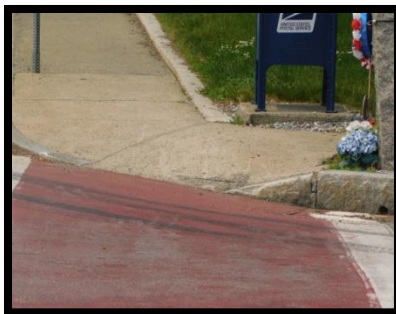
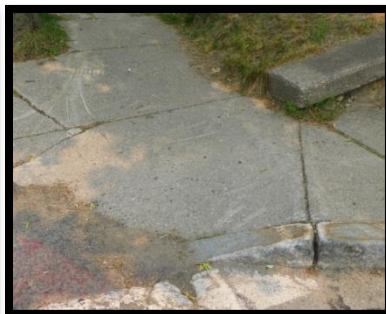
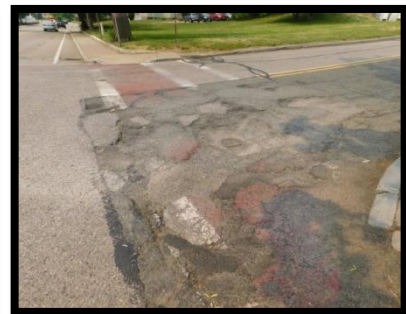
- The crosswalk across Miles Street has curb ramps that lack detectable warning strips and level landings on both sides. Curb ramp running slopes vary from 9.8% to 12.4%.
- The crosswalk at #74 and Saint Brigid Church across Main Street has curb ramps that lack detectable warning strips and level landings on both sides. The crosswalk enters into a driveway at the #74 side and 4" to 5" of granite curbing on Saint Brigid's side. The curb ramp on the Saint Brigid's side is also an apex curb ramp.
- The crosswalk across Hamilton Street has curb ramps that lack detectable warning strips and level landings on both sides. Curb ramp running slopes vary from 11.2% to 18.2%. The crosswalk is also severely deteriorated with up to 3" abrupt changes in level surface and gaps in the pavement.

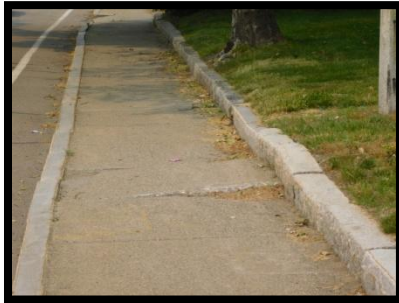
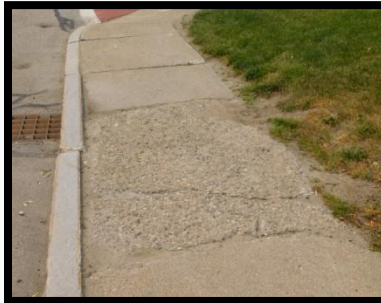
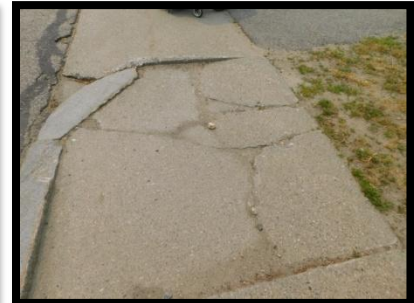
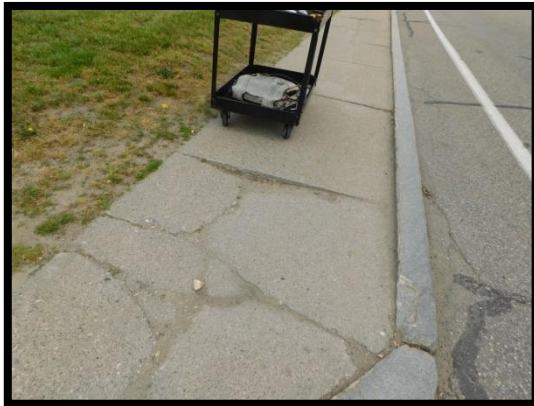
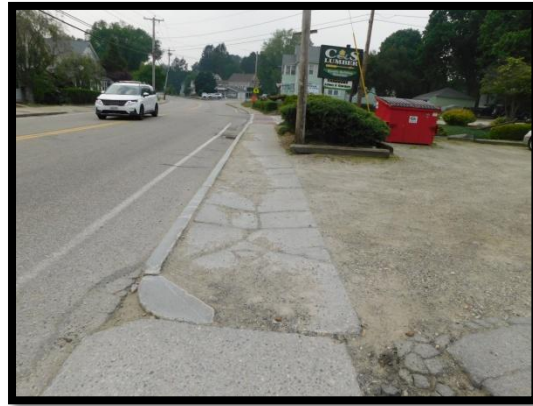
- The sidewalk immediately past Hamilton Street has sidewalk heaving and abrupt changes in level surface.
- The concrete sidewalk at Millbury Family Dentistry has severe sidewalk deterioration with abrupt changes in level surface of up to 1" +.
- There is a ½" abrupt change in level surface at the transition from sidewalk to #122 driveway.
- The sidewalk at C & S has severe deterioration with heaving and abrupt changes in level surface of up to 2". Approximately 100 feet of sidewalk has missing concrete, gaps, and excessive cross slopes up to 11.0%.

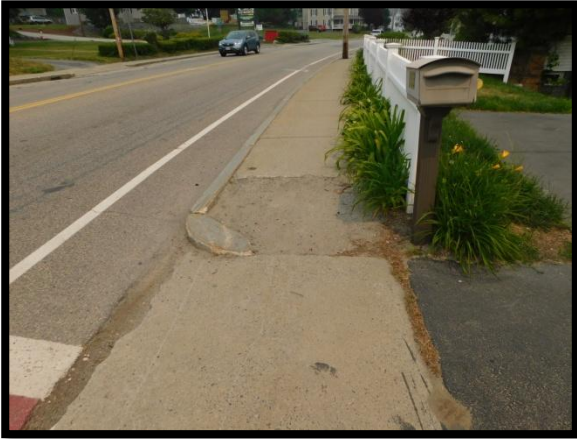
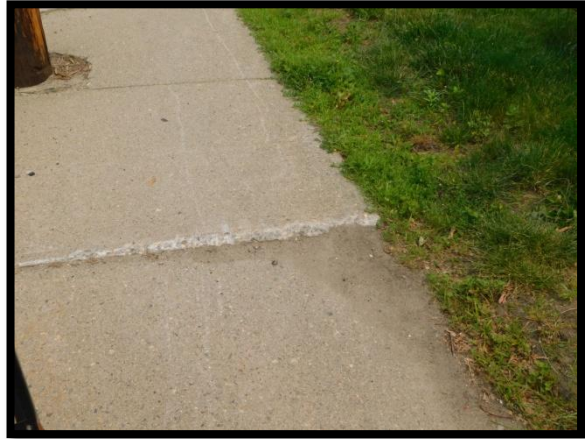
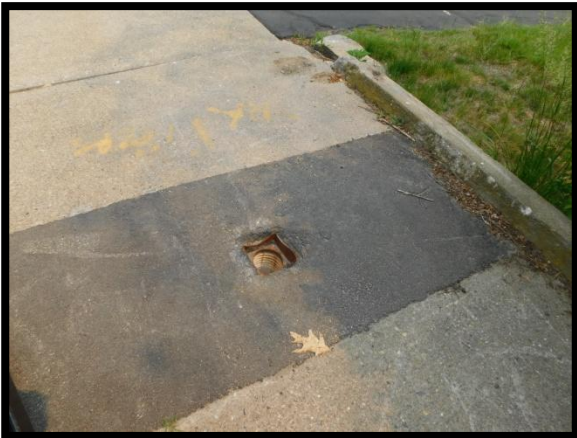
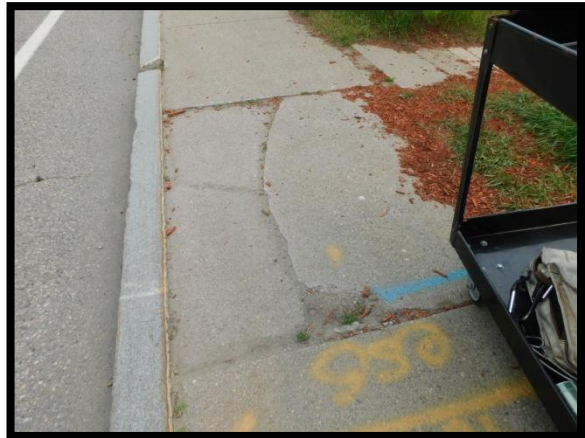
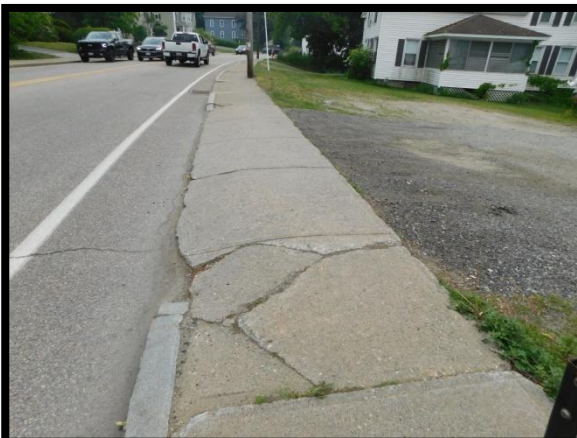
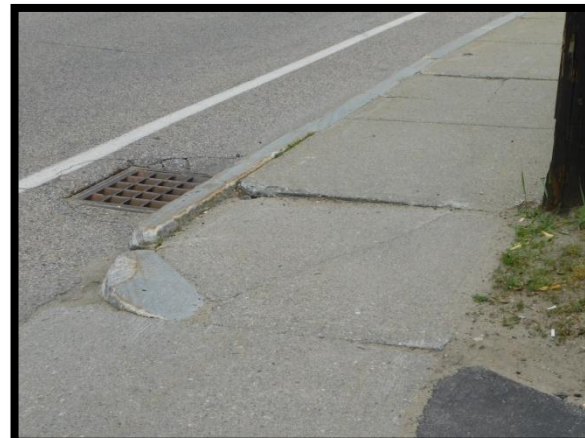
- The sidewalk clear width at the Mulhane Funeral driveway is reduced to 15" as a result of deteriorated concrete and granite curbing. There is also a 1" abrupt change in level surface.
- The sidewalk – driveway transition at Sunrise Detox has a 1" gap and a 1" abrupt change in level surface.
- There is a 1" abrupt change in level surface at the asphalt sidewalk and concrete sidewalk transition at Farnsworth Court on the Millbury Baptist Church side.
