Town of Millbury Accessibility Plan

***Town of Millbury Accessibility Plan
November 2006***

***Prepared by: James M. Mazik, AICP
Consulting Services
P.O. Box 333 – 130 Ruggles Hill Road
Hardwick, Massachusetts 01037
(413) 477-0914 – (413) 265-9454
jmazik14@comcast.net***

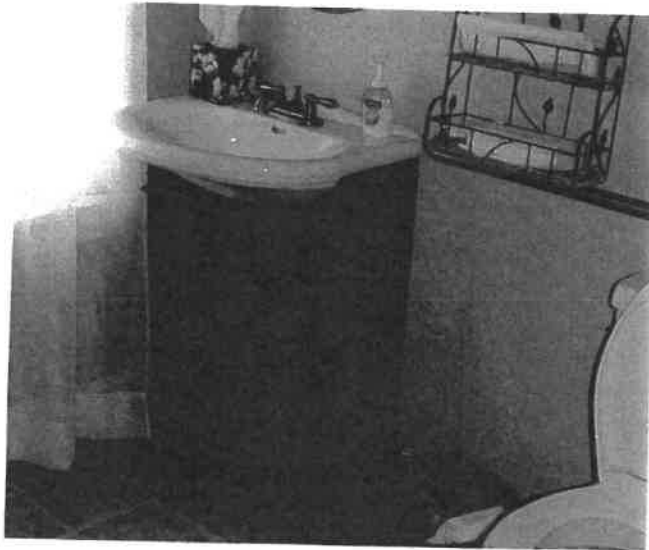
| 12. Women's bathroom - lack of accessible signage on latch side of door; non-compliant knob-style door hardware; hand-held soap dispenser; mirror mounted 48" at bottom a.f.f.; water closet exceeds the nearest sidewall setback requirement by 4 1/2"; flush valve mounted on the nearest wall side as opposed the approach side; only one 36-inch "smooth surfaced" grab bar provided on the side wall side and does not appear to be properly secured to wall studs or blocking; sink exceeds maximum rim height requirement by 2" and does not provide adequate 27" knee clearance below | S. 4.13

Renovate bathroom by replacing or modifying to comply as follows: 3 3 \$4,500

Sink - maximum height of 34" to rim, minimum of 22" from wall to front of sink, minimum 27" clear knee space below rim, bowl depth not to exceed 6"; all pipes below sink must be wrapped; faucets must be operable with one hand or a closed fist; self-closing valves shall remain open for at least ten seconds.

Signage - install accessible compliant signage with appropriate finish and contrast and character height and proportions. Raised and Brailled characters should also be included. Signage should be mounted at 60" a.f.f. o.c. adjacent to the latch side of the door.

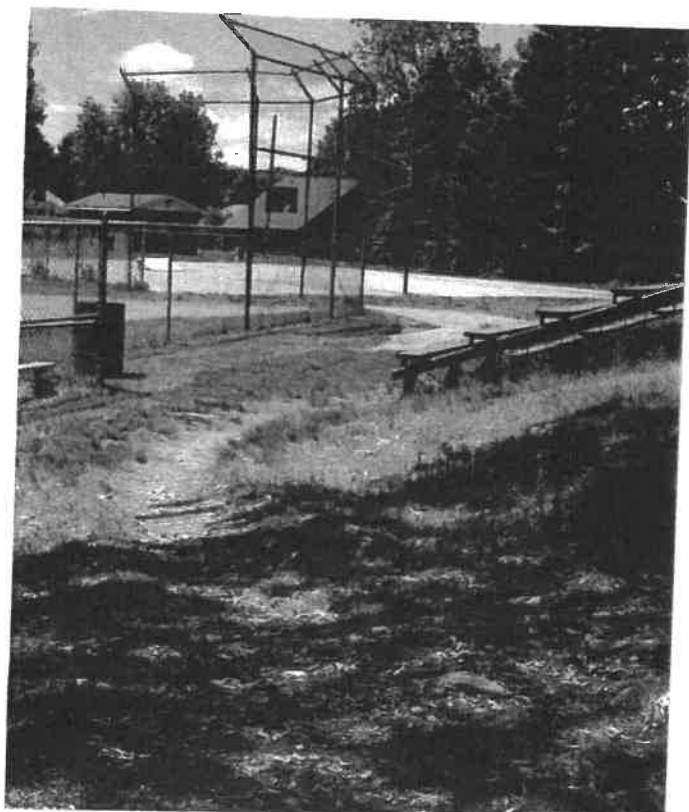
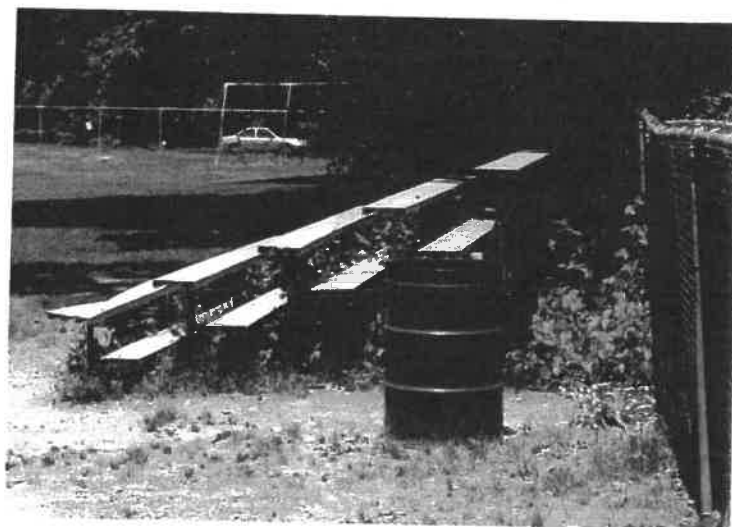
2.	No accessible route of travel exists to the ball fields, play components and basketball courts.	Construct a 48" wide w/36" clear width accessible pathway to all ball fields, play components and the basketball courts.	1	3	\$20,000

3.	Lack of railings in bleachers.	Install accessible compliant railings.	1	3	\$600
4.	No accessible swing sets exist in the play area.	Based on number of swings, add one accessible swing seat.	1	2	\$350
Total					\$28,450

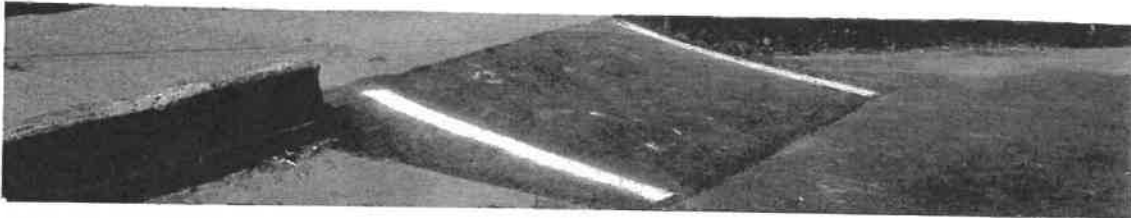
1. *No designated accessible parking space, line striping or signage.* *Designate one 8' wide accessible passenger vehicle parking space and one 8' wide van accessible parking space, separated by a 8' wide accessible access aisle. Provide related striping and accessible signage.* 1 2 \$250
2. *No accessible route of travel exists to the ball fields, tennis courts and related facilities.* *Construct a 48" wide w/36" clear width accessible pathway to all playing fields and facilities.* 1 3 \$30,000
3. *Asphalt and wooden "walkways" to the pavilion exceed the maximum running slope requirement of 5.0% for walkways and 8.3% for ramps.* *Remove and reconstruct existing walkways to comply with accessibility requirements. This should include a maximum running slope of 5.0% and cross-slope of 2.0%.* 1 3 \$1,500

4. *Public bathrooms in pavilion are wholly non-compliant including door hardware, signage, dispensers and all toilet fixtures.* *Construct fully compliant men's and women's accessible bathrooms.* 3 4 \$16,000

5. *The counter height at the concession stand is constructed at 39 ¼" a.f.f., which exceeds maximum height requirements by nearly 6".* *Construct a counter below the dispatch window with a maximum height of 34" with a minimum of 27" knee clearance.* 2 3 \$400

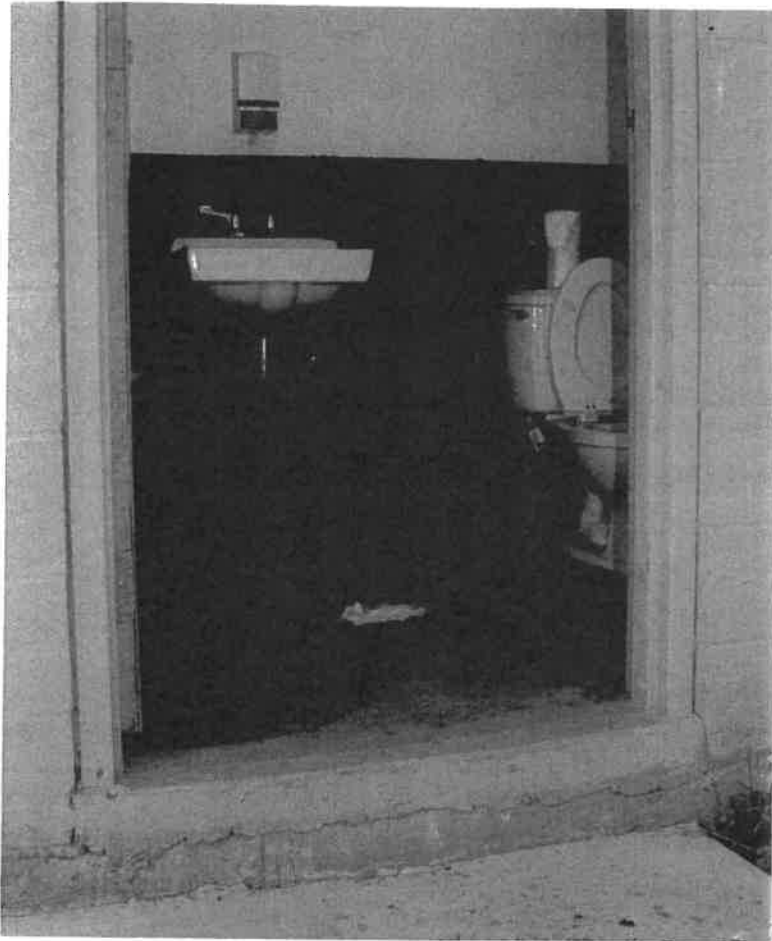
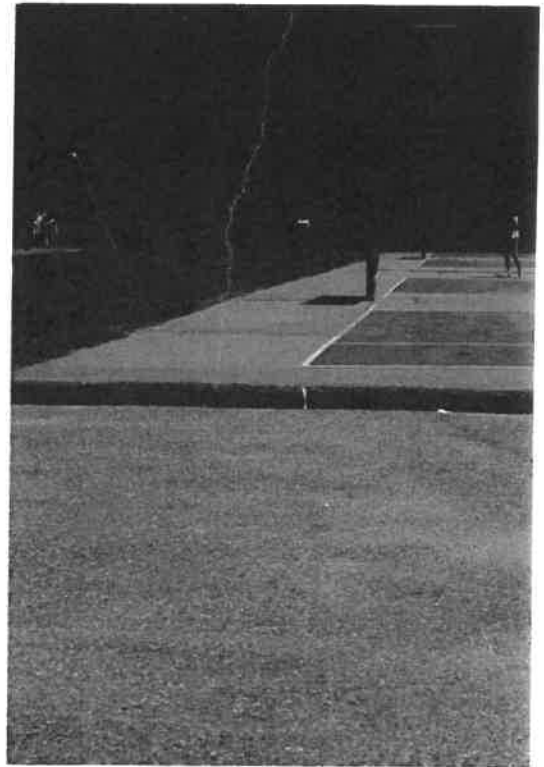
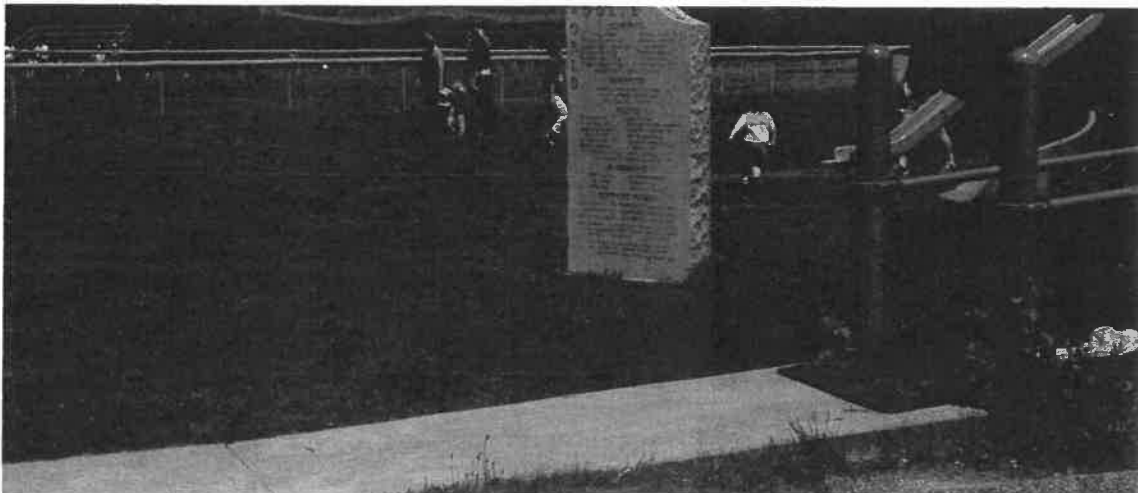
Jacques Park: A rural "neighborhood" park with minimal improvements and in an overall "poor" condition. The park consists of an overgrown and inaccessible basketball court, a baseball field, 6 swings, 2 bleachers and an accessible portable toilet. The basketball court appears to be abandoned due to the extensive overgrowth and condition of the court. In addition, no formal parking exists adjacent to the basketball court. Should the basketball court be put back into use, it will need to be made compliant by creating an accessible route of travel to this facility. The parking for the baseball field and swings is an unimproved and unstable gravel surface and therefore non-compliant. No signage or striping is provided. The "accessible" portable toilet is located on an unimproved and uneven gravel and grassed surface rendering it non-accessible. No accessible route of travel exists to the ball field, bleachers or swings. Railings are not provided on the bleachers. None of the swings are accessible.

<u>General Description of Obstacle Which Limits Mobility or Access</u>	<u>Type of Action to be Taken</u>	<u>P</u>	<u>F</u>	<u>Cost Estimate</u>
1. No designated accessible parking space, line striping or signage.	Surface an approximately 600 s.f. area to create a firm and level parking area next to the main entry. Designate one 8' wide accessible passenger vehicle parking space and one 8' wide van accessible parking space, separated by a 8' wide accessible access aisle. Provide related striping and accessible signage.	1	2	\$7,500
2. No accessible route of travel exists to the ball fields, play components and "accessible" portable toilet.	Construct a 48" wide w/36" clear width accessible pathway to the baseball field, swings and the designated location of the portable toilet.	1	3	\$20,000
3. Lack of railings in bleachers.	Install accessible compliant railings.	1	3	\$400
Total				\$27,900

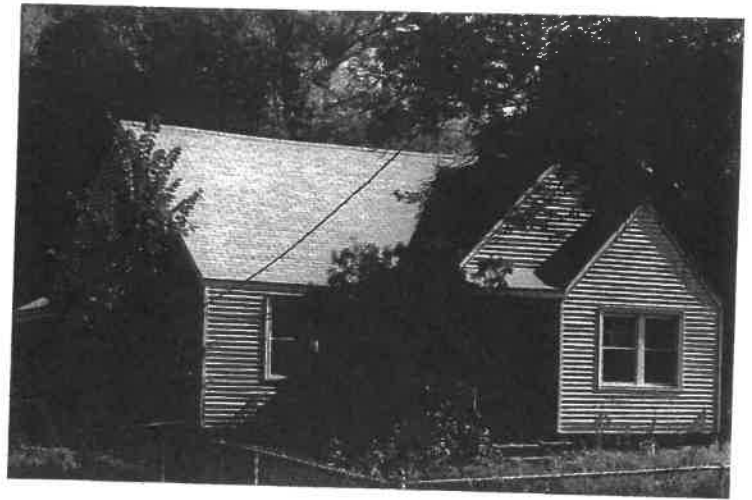
Property Location: 256 No. Main Street
No. of Buildings: 1
No. of Units: 1
Accessible Units 0
Housing Type: 1½-story colonial
Year Built: 1938

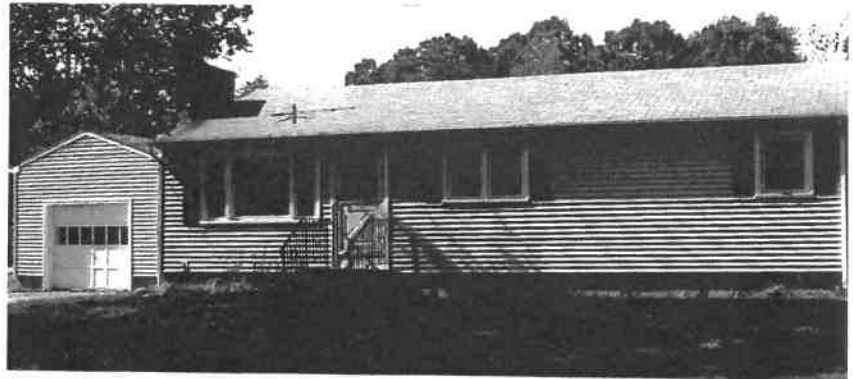
Property Location: 47 Riverlin Street
No. of Buildings: 1
No. of Units: 1
Accessible Units 0
Housing Type: 1-story ranch
Year Built: 1955

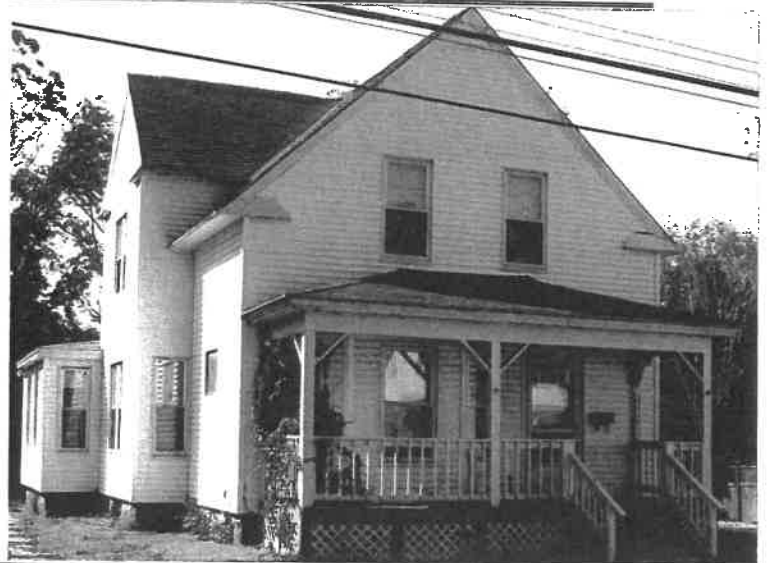
Property Location: 7 Waters Street
No. of Buildings: 1
No. of Units: 1
Accessible Units 0
Housing Type: 2-story farmhouse
Year Built: Est. 1900

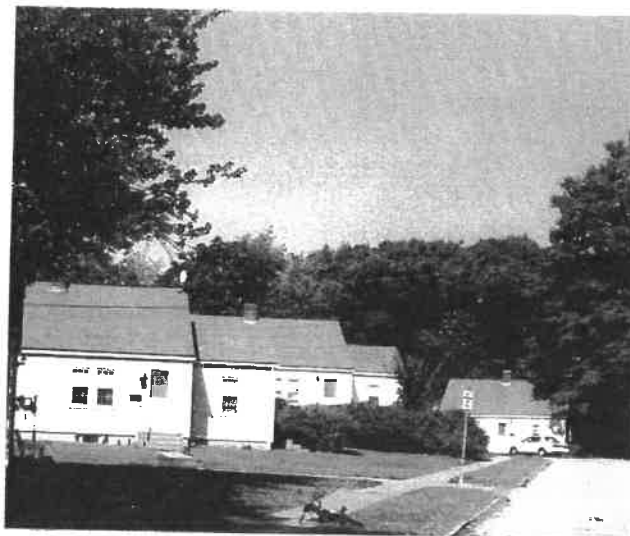
Property Location: Memorial Drive
No. of Buildings: 25
No. of Units: 25
Accessible Units 0
Housing Type: 1½-story cape(s)
Year Built: 1950-60

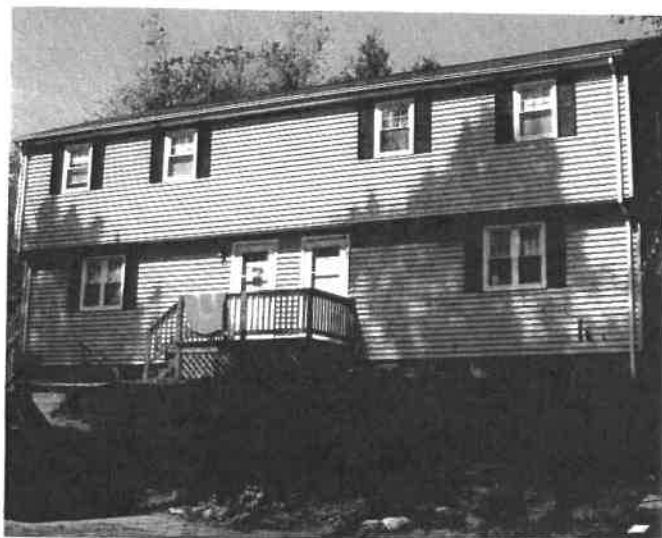
Property Location: 230 West Main Street
No. of Buildings: 1
No. of Units: 2
Accessible Units 0
Housing Type: 2-story garison
Year Built: 1970

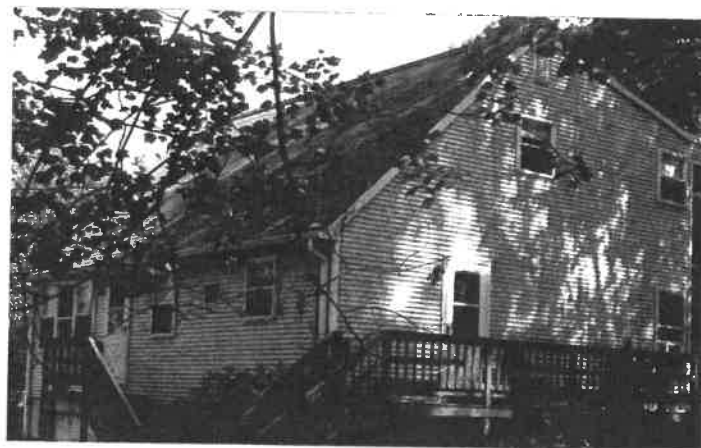
Property Location: 21 Forest Drive
No. of Buildings: 1
No. of Units: 2
Accessible Units 0
Housing Type: 1½-story cape
Year Built: 1963

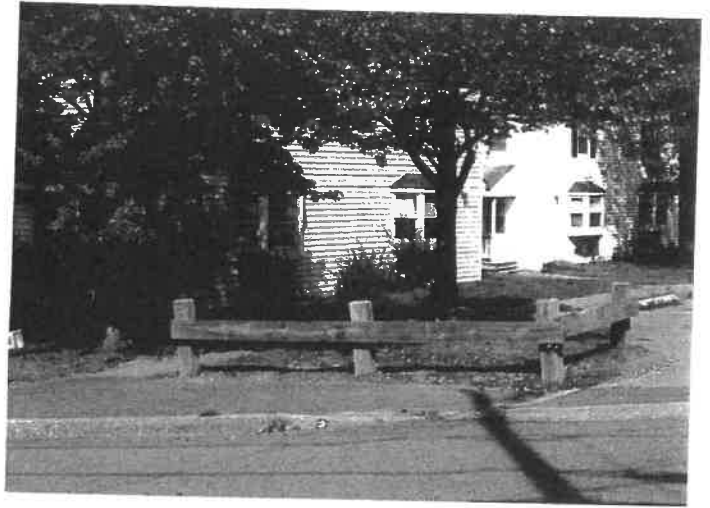
Property Location: 9-13 Burbank Street
No. of Buildings: 3
No. of Units: 6
Accessible Units 0
Housing Type: 2-story colonial
Year Built: 1985

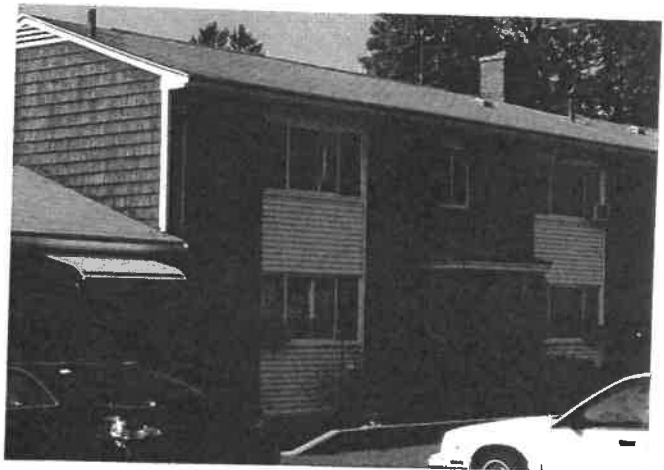
Property Location: 2 Pearl Street
No. of Buildings: 4
No. of Units: 32
Accessible Units 0
Housing Type: 2-story apartment
Year Built: 1960

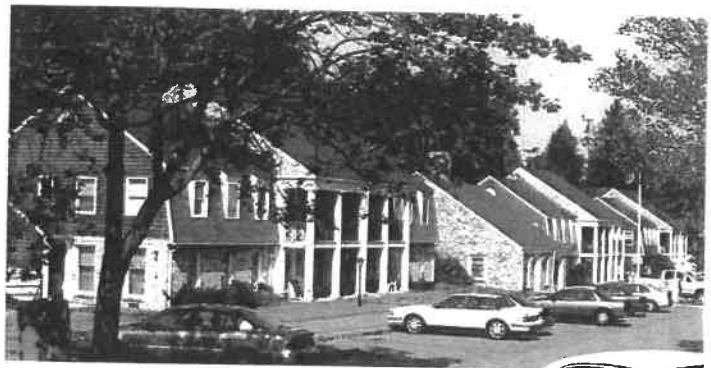
Property Location: Colonial Drive
No. of Buildings: 5
Accessible Units 0
No. of Units: 60
Housing Type: 3-story apartment
Year Built: 1974

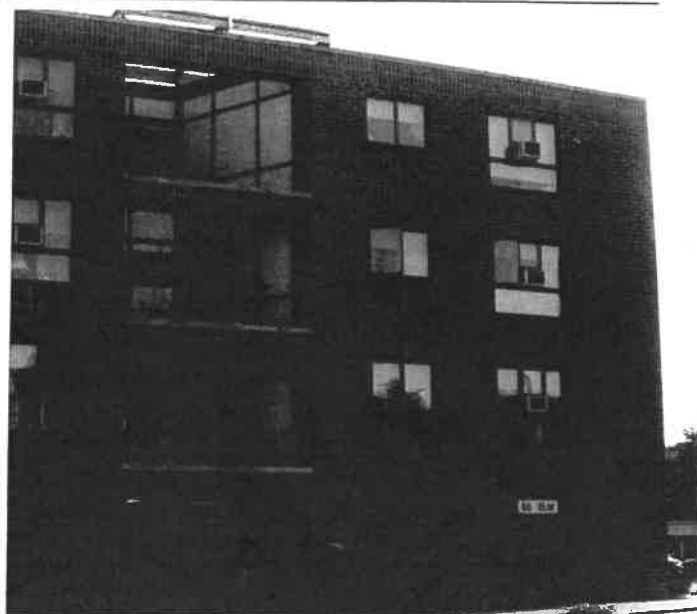
Property Location: 95 Elm Street
No. of Buildings: 1
No. of Units: 54
Accessible Units 3
Housing Type: 4-story apartment.
Year Built: 1980

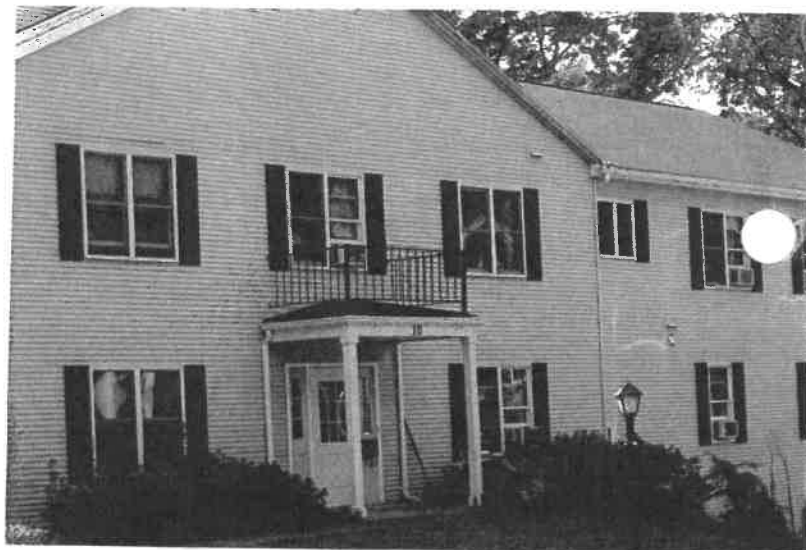
Property Location: 10 Colonial Drive
No. of Buildings: 1
No. of Units: 5 (23 bedrooms)
Accessible Units 1 (4 adaptable)
Housing Type: 2-story building
Year Built: 1989

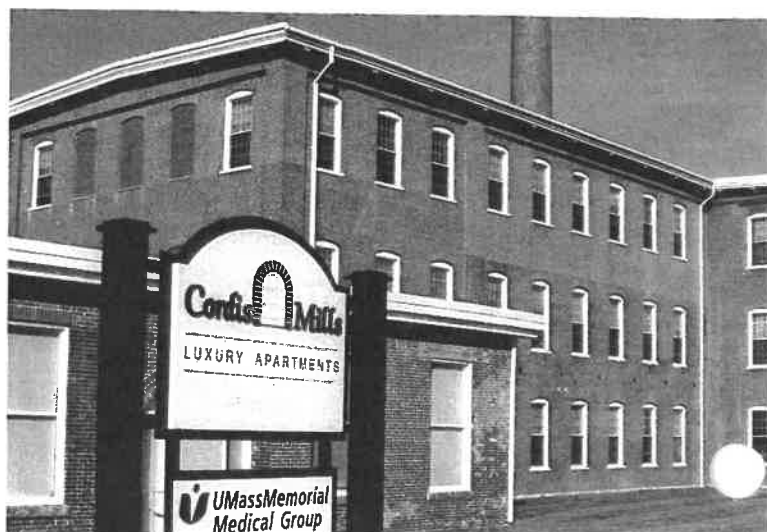
Property Location: Canal St.(Cordis Mills)
No. of Buildings: 1
No. of Units: 112
Accessible Units 6
Housing Type: 3-story building
Year Built: 1900 (2004 renov.)
