**Town of Millbury
Self-Evaluation and Transition Plan
June 2023**

TOWN OF MILLBURY – SELF-EVALUATION AND TRANSITION PLAN

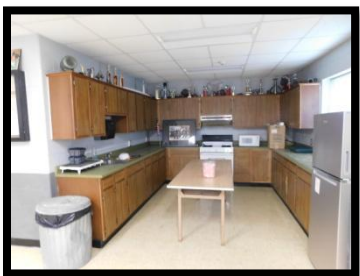
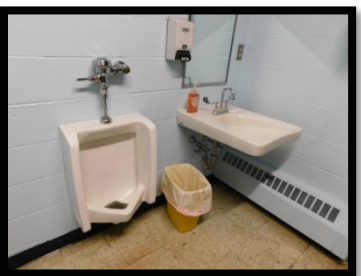
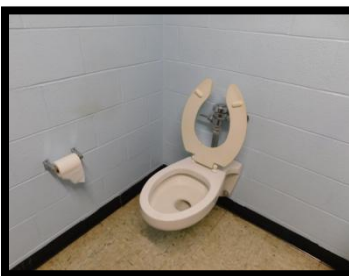
There is no designated accessible parking. The meeting/dining room has a sink/counter that is 2" too high and lacks knee clearance. The cabinets lack hardware and the soap and towel dispensers are too high. Light switches and a wall mounted telephone are not within reach range. Doors have glass panes that are too high under the 2010 ADA Standards and lack tactile designation signage.

The 2 bathrooms (men and women) lack tactile designation signage and have doors with excessive operating forces and doors that close too fast. Sinks have piping that lack insulation. Dispensers are too high. The water closets lack grab bars and have non-compliant near, far, and/or front clear widths. The men's bathroom also has a water closet flush control on the wrong side, a toilet paper dispenser that is too close to the front of the water closet, and a shower that lacks accessible features and is too small for a wheelchair user.

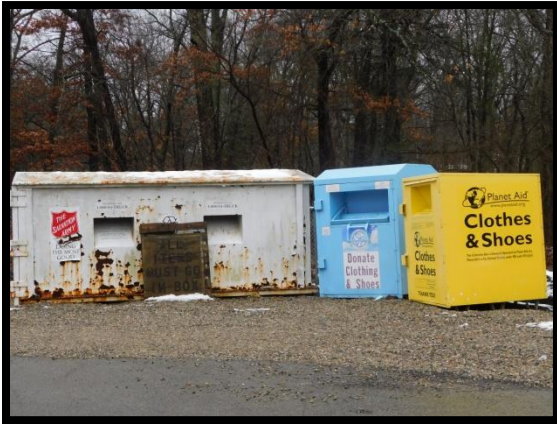
Photo Transfer 3

The donation bins (Planet Aid, Salvation Army, St. Vincent dePaul) are at heights which exceed acceptable reach standards under ADA by 3" to 12". In addition, the St. Vincent DePaul bin requires more than 5 lbs. of force to use. The bins are located on loose stone, which is not an acceptable base as an accessible route of travel. [See Photo Transfer 3.](#)

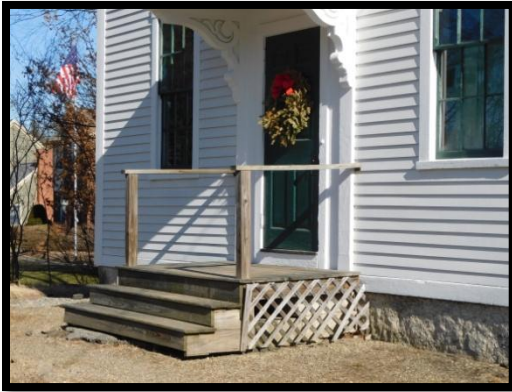
Photo Grass Hill 1

Front Entrance The front stairs have ¾" unbeveled nosings. There are no railings for the actual stairs with a rectangular railing located on the landing. There is no accessible route of travel into the building. See Photo Grass Hill 1.	504.5	27.3	In order to achieve accessibility at the sole main entrance door, the stairs will need to be replaced with a ramp in accordance with Sections 405 and 505 of the 2010 ADA Standards and Section 24 of 521 CMR. Actual costs will vary according to construction type and materials.	1	3,4	N	TBD – up to \$75K+
	505	27.4

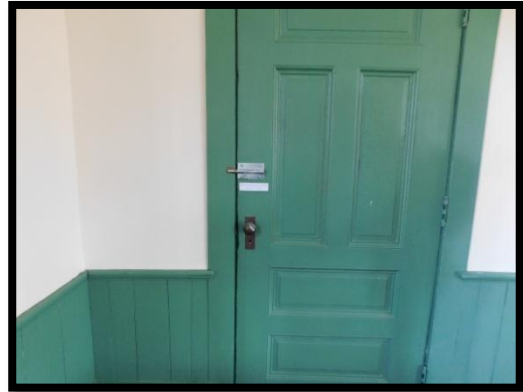
Photo Grass Hill 2

206.2.1	20.1					
Door Hardware The front main door, basement, egress door have knob-style hardware. See Photo Grass Hill 2.	404.2	26.11	Replace the hardware with lever style or similar compliant door hardware.	1, 2	2	I	\$300
Door Signage Tactile designation signage is not provided on the basement, bathroom, and egress doors. See Photo Grass Hill 2.	703	41.1	Install accessible compliant tactile designation signage so that it is located on the latch side of each door with appropriate finish and contrast and character height and proportions, raised and brailled characters should also be included. Under 521 CMR, signage s/b 60" a.f.f to the centerline of the sign. Tactile characters on signs s/b 48" min. a.f.f.. from baseline of lowest character and 60" max. a.f.f. to baseline of highest character. Characters must meet the ADA Standards for character height, finish and contrast, accompanied by Grade 2 Braille (703 ADA Standards). Accessible bathrooms must also include the Universal Symbol of Accessibility.	2, 3	2	I	Up to \$150

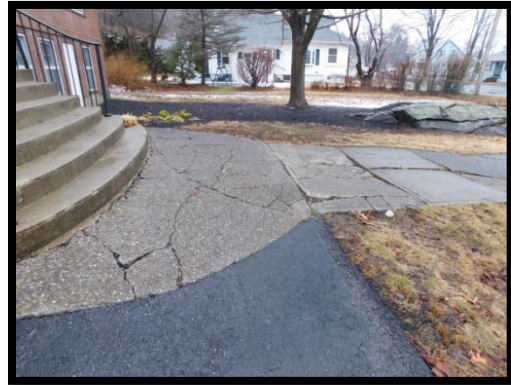
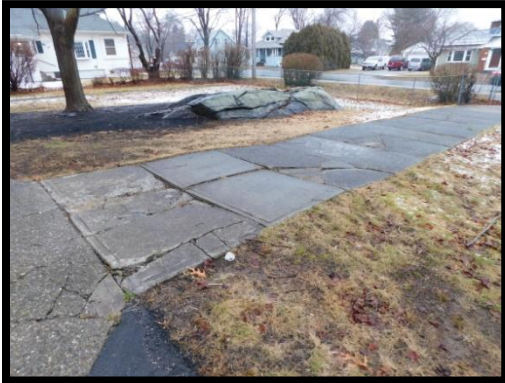
The front concrete walkway is severely deteriorated with excessive heaving and abrupt changes in level surface. [See Photos DMS 2 and 3.](#)

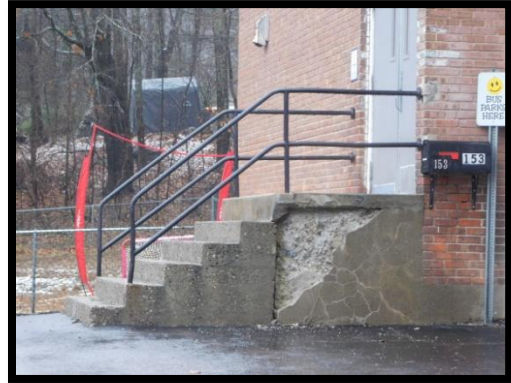
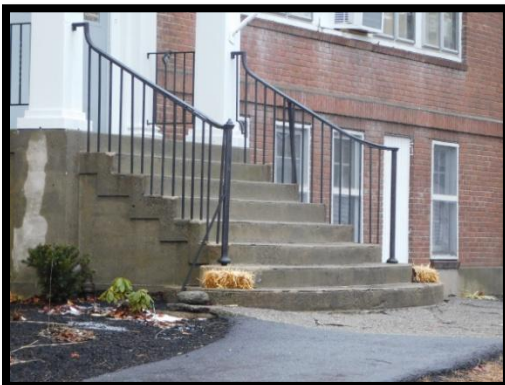
The concrete stairs (front and 2 side entrances) are weathered and deteriorated, not uniform in height, and in some areas exceed the maximum rise of 7 inches. [See Photos DMS 4 and 5.](#)

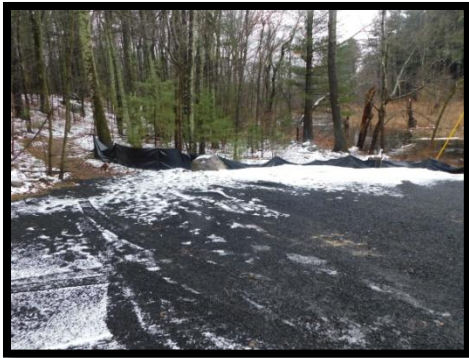
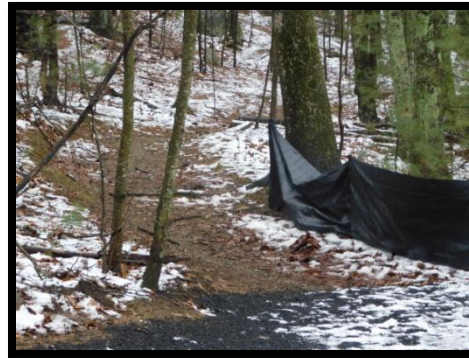
Colton Road Conservation Area

Description of Facilities: These are unimproved properties (trails only or grassed surfaces) with no formal or limited parking. Parking surfaces are grass, loose stone, gravel, and/or asphalt shavings. Although there are paths and trails at some of these sites, none are formally maintained to a standard that would be considered to be an accessible route of travel.

These areas would require modifications to parking (level and firm, stable surface; signage; striping) if the sites are improved, expanded upon, or if amenities such as picnic tables, benches, or grilling areas are added to the facilities. At the time of assessment, no formal amenities, including portable toilets, were found at the sites. Brierly Pond has 2 “ornamental” stone benches at the road side. At a minimum, compliant accessible routes of travel (maximum 5.0% running slope without railings, maximum 2.0% cross slope; minimum 4 feet in width with 3 feet of clear space; stable, firm, slip resistant surface; and no greater than ¼” abrupt change in level surface) would need to be provided to the enhanced or added service or amenity. Unless formal parking, trail improvements, or amenities are initiated, no further action is required at the present time.

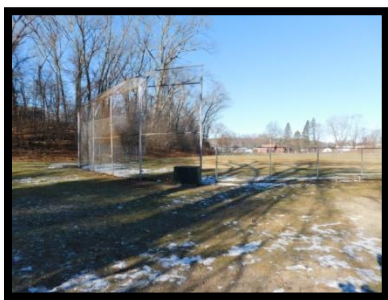
Photo East Millbury 1

General Description or Obstacle Which Limits Mobility or Access: There is no designated accessible parking on site and no accessible route of travel to the baseball fields, player's seating, basketball courts, bench, swings, and other play components. There is no level area for a wheelchair at the bench.

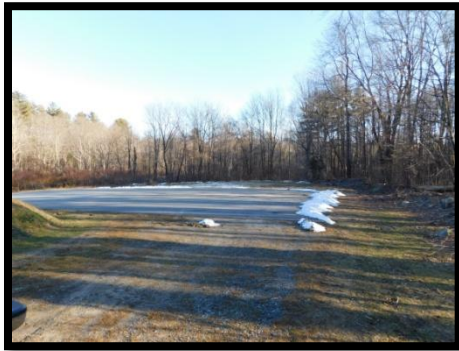
Photo West Millbury 1

General Description or Obstacle Which Limits Mobility or Access: There is no designated accessible parking on site and no accessible route of travel to the baseball field, player's seating, benches, and play equipment. There is no level area for a wheelchair at the benches.

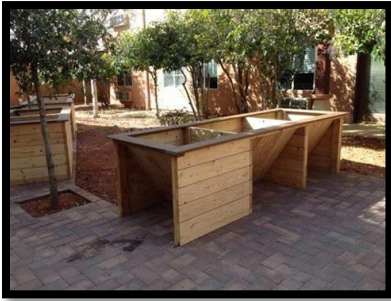
Photo Butler Farm 1

General Description or Obstacle Which Limits Mobility or Access: The designated accessible parking has signage that is too low, lacks striping, lacks access aisles, and has excessive cross slopes of up to 3.7%. There is no accessible route of travel to and around the dog park and to its various amenities. There are no level areas next to the benches in the dog park. The approximately 7 chain link gates are not smooth at the base on the push side of the gates. There is no accessible route of travel to the community garden.

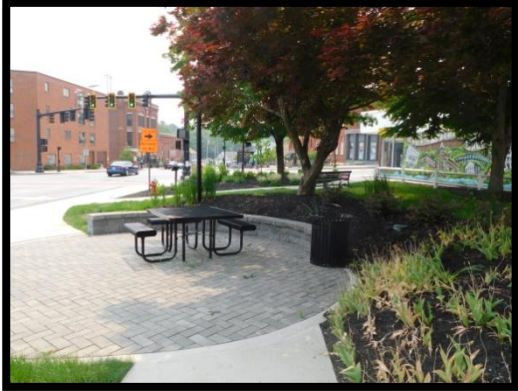
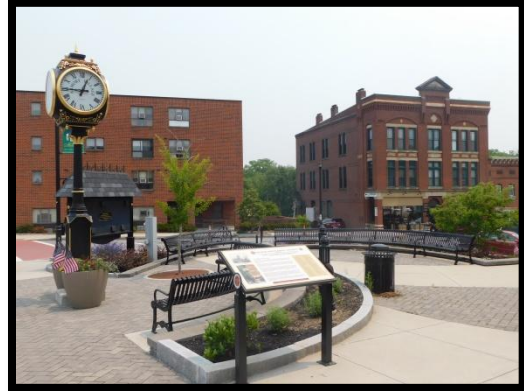
The trash receptacle next to a bench in the Upper Town Common restricts the level area for a wheel chair. It is recommended that the trash receptacle be relocated.

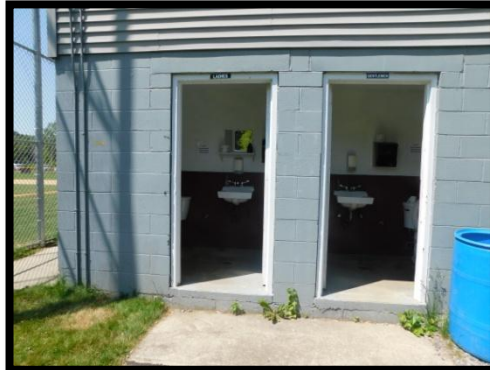
Photo Washington 6

<p>The flush control of the water closet is on the wrong side.</p> <p>See Photos Washington 6 and 7.</p>	604.6	30.7.5	<p>Replace the water tank or the water closet in entirety such that the flush control is on the wide or approach side.</p> <p><i>Note: It may be necessary to engage in a design professional to determine the best way to achieve compliance including clear widths and turning radius requirements. This may require internal demolition and/or building addition. An alternative would be to close the bathrooms to the public and place out of service in entirety and use portable regular and accessible toilets at the baseball field.</i></p>	3	2	N	\$500
<p><u>Accessible Route of Travel and Other Amenities</u></p> <p>There is no accessible of travel fully around the playground area (Woolie World), ground components, swings, benches (2), and picnic tables (4). Shredded rubber is the sole surface treatment around the Woolie World playscape. The route of travel to the accessible swing is loose stone and shredded rubber.</p> <p>The 7.5 foot long concrete ramp to the playscape has a running slope that varies from 6.4% to 6.6%.</p> <p>There is also a ¾" abrupt change in level surface at the transition from concrete to the playscape.</p> <p>There are no level areas for a wheelchair at the benches.</p> <p>There is no accessible route of travel to the baseball field, dugouts, and batting cage from the parking area. The surface treatment of the walkway from the parking to the "home" dugout and baseball field is non-compliant loose stone. There are 2" to 4" abrupt changes in level surface to enter the dugouts.</p> <p>The picnic tables have only 10" of knee depth.</p> <p>The chain link gates to the basketball court (1), baseball field (2) and batting cage (1) do not comply with the 2010 ADA Standards for a smooth surface within 10 inches of the ground on the push side for the full width of the gate.</p> <p>See Photos Washington 8, 9, 10, 11, 12, and 13.</p>	<p>402</p> <p>303</p> <p>403</p> <p>1008</p> <p>802.1</p> <p>221.2</p> <p>226.1</p> <p>902</p> <p>404.2.10</p>	<p>19</p> <p>20</p> <p>22</p> <p>14</p>	<p>Construct an accessible route of travel to and around the playground, ground components, swings, benches, picnic tables, baseball field, dugouts, and batting cage. This will require replacement of the concrete ramp to Woolie World such that the running slope does not exceed 5.0%. It will also require modifications to the baseball dugout entrances. In addition, there must be an accessible route within the playground area connecting play components as the shredded rubber does not comply with the requirements for an accessible route of travel.</p> <p>The accessible route of travel must be compliant with width (48" per 521 CMR) and slope (2% max. cross, 5% max. running) requirements as well as changes in level surface (no > than ¼" unbeveled or between ¼" and ½" beveled w/a slope of no > 1:2). Create an approach and level wheelchair area next to the benches. The space should be 36" wide x 60" deep per wheelchair. If a front/rear approach, the depth can be reduced to 48" as opposed to 60" for a side approach. Construction options include compacted stone dust, asphalt or similar surfaces that meet the requirement of stable, firm, and slip resistant. Costs will vary depending on material used.</p> <p>Provide an additional picnic table which provides the required 27" knee height, 30" clear width, and 19" knee depth and locate on an accessible route of travel.</p> <p>Install smooth plating or at the base of the gate.</p>	2	3	N	Up to \$35,000+

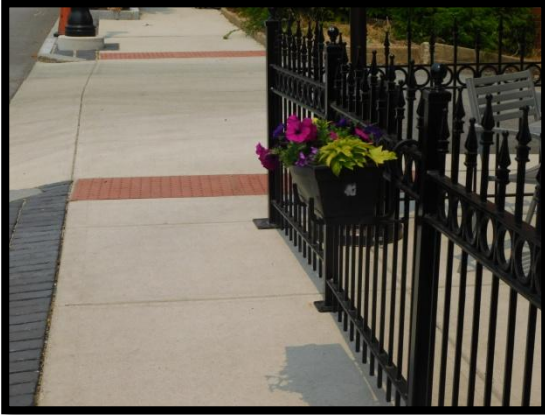
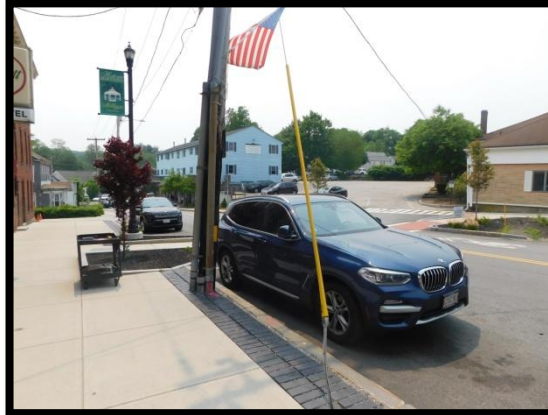
- Telephone pole #2 at the Belfont Hotel has a guy wire which restricts head clearance and is a protruding object.

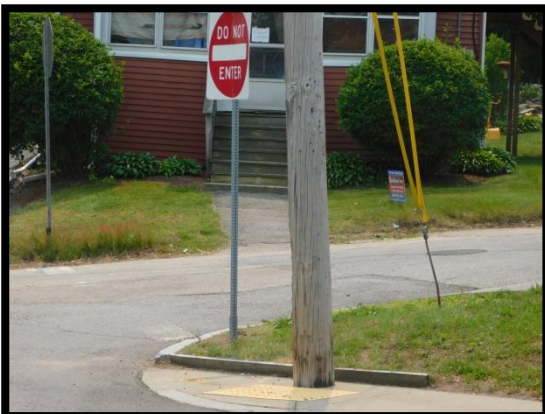
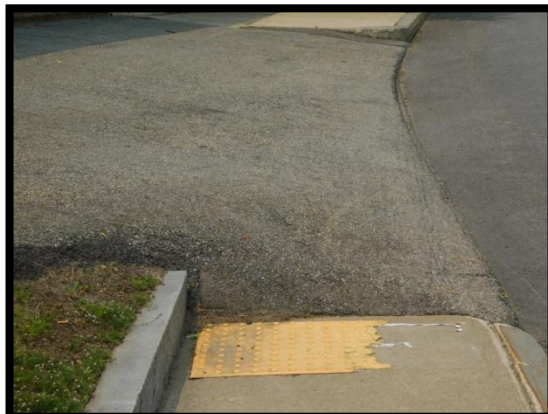
- The sidewalk at the #12 Apartments has up to a 12" abrupt change in level surface at the driveway.
- The sidewalk/driveway at the #12 Apartments has up to a 28% cross slope.
- The sidewalk clear width at the telephone pole and curb ramp at School Street and South Main Street is reduced to only 34".

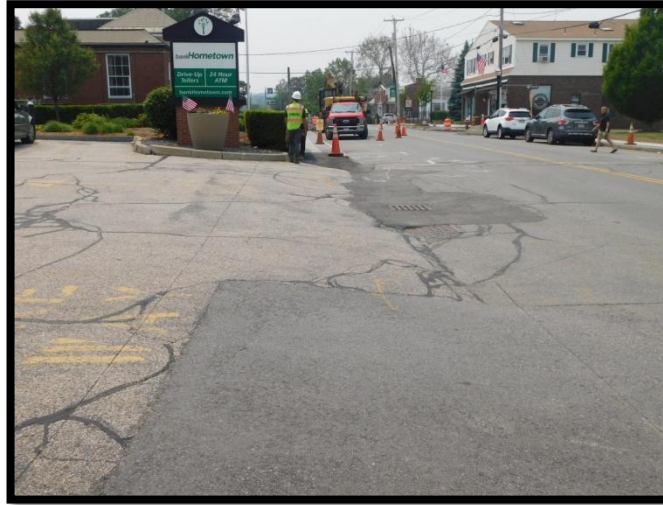
- The sidewalk/driveway at the Hometown Bank has a cross slope of 7.0% to 10.2%.

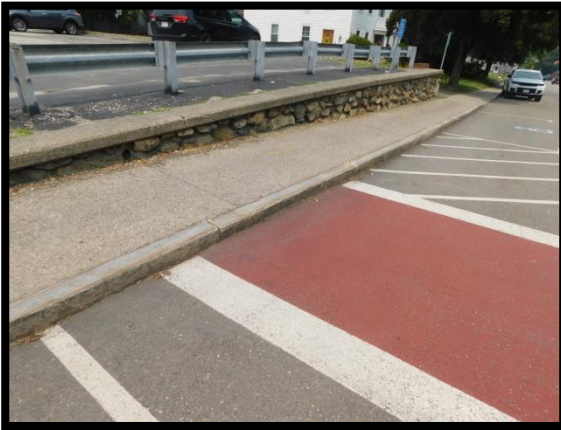
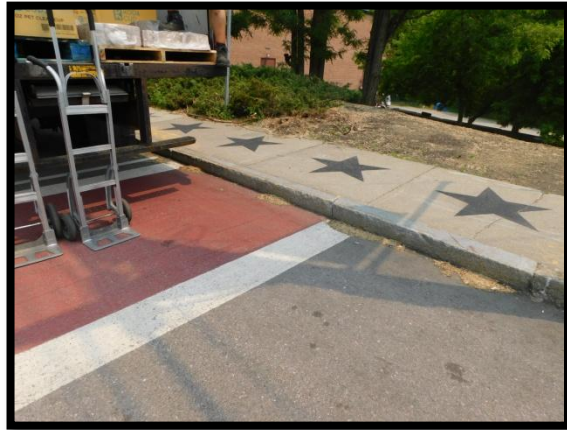
- The crosswalk across Elm Street at A & D Pizzeria and Mykonos Bakery has curb ramps that lack detectable warning strip and have up 4" to 6" granite curbing on both sides.

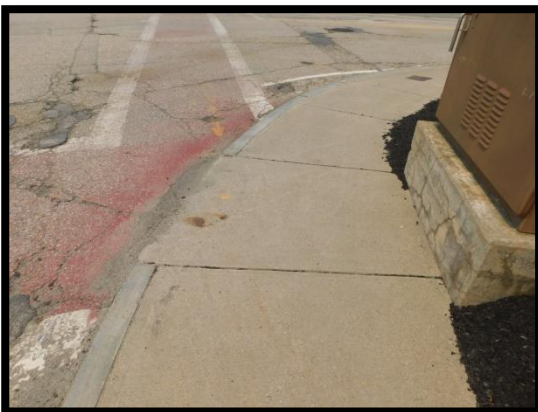
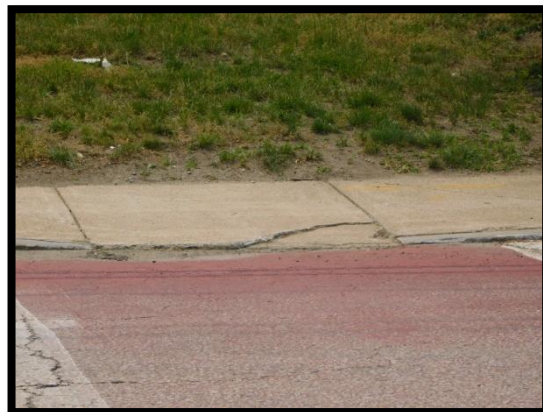
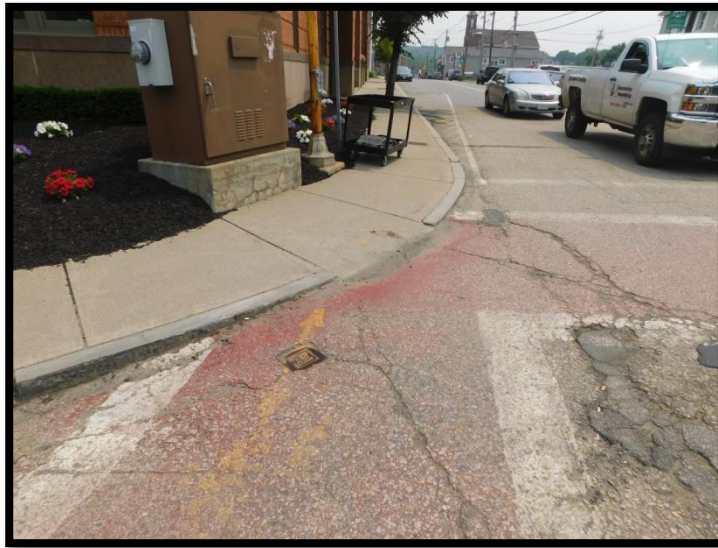
- The crosswalk across Main Street at Canal Street has curb ramps that lacks detectable warning strips and level landings on both sides.
- The crosswalk across Canal Street at Main and Canal Streets has curb ramps that lack detectable warning strips and level landings on both sides. The curb ramp on the Millbury Credit Union side is an apex curb ramp and has up to a 2½" abrupt change in level surface at the curb ramp (granite curbing).

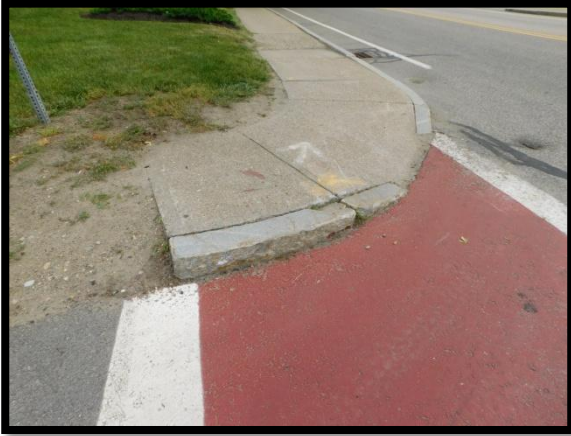
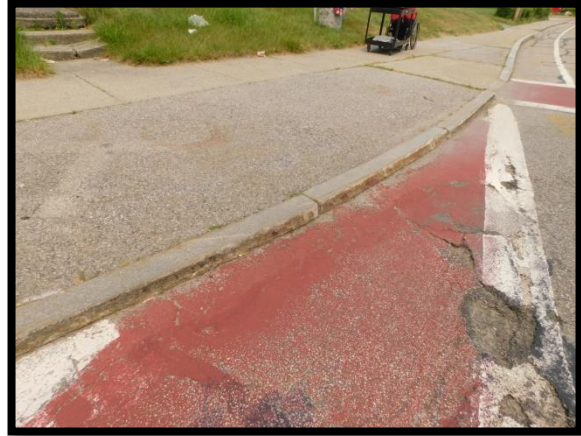
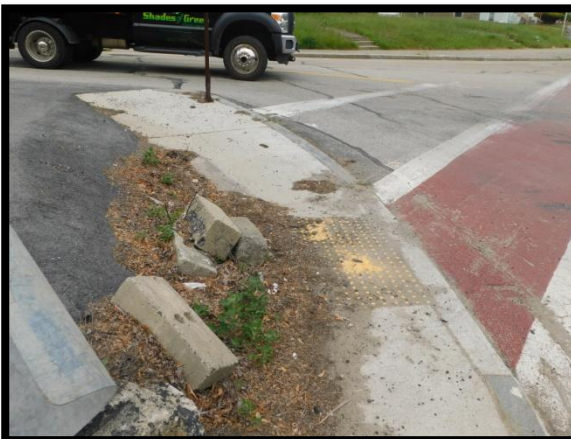
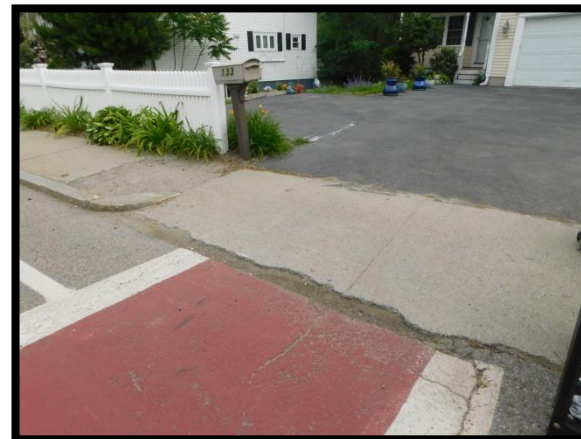
- The crosswalk across Highland Street has curb ramps that lack detectable warning strips and level landings on both sides. Curb ramp running slopes vary from 13.6% to 14.0%.
- The crosswalk across Orchard Street has curb ramps that lack detectable warning strips and level landings on both sides. Curb ramp running slopes vary from 14.2% to 18.0%. The crosswalk also enters into up to 5" of granite curbing.
- The crosswalk across Goff Street has curb ramps that lack detectable warning strips and level landings on both sides.
- The crosswalk across Martin Street lacks a curb ramp on the C & S side and enters into 3" granite curbing. The curb ramp on the opposite side (North Main Street) has up to a 14.0% running slope to the detectable warning strip. There is no level landing due to the accumulation of debris.

- The crosswalk at Martin Street across Main Street has curb ramps that lack detectable warning strips. The curb ramp on the Martin Street side has a running slope up to 18.4%. The curb ramp on the opposite side has up to a 5" gap, 1"+ abrupt change in level surface, no level landing, and enters into a driveway.

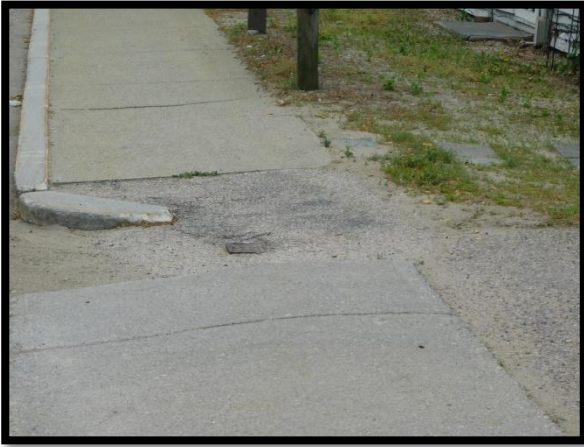
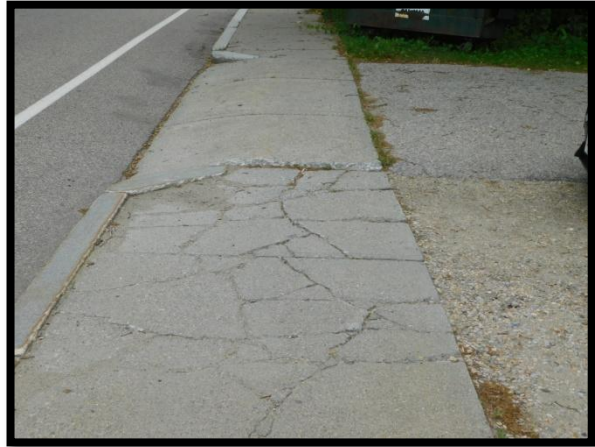
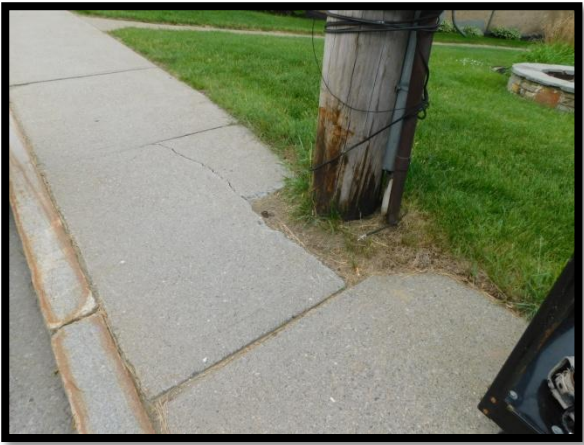
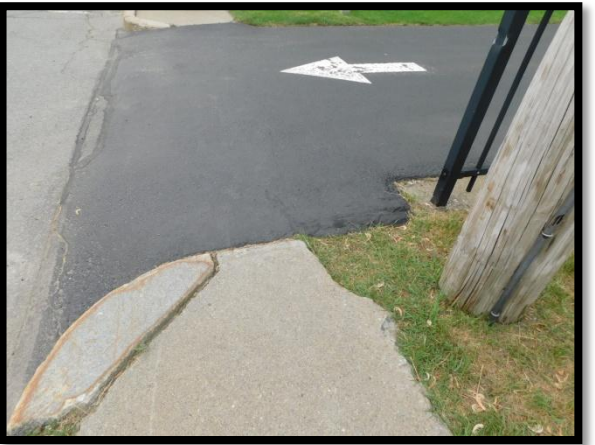
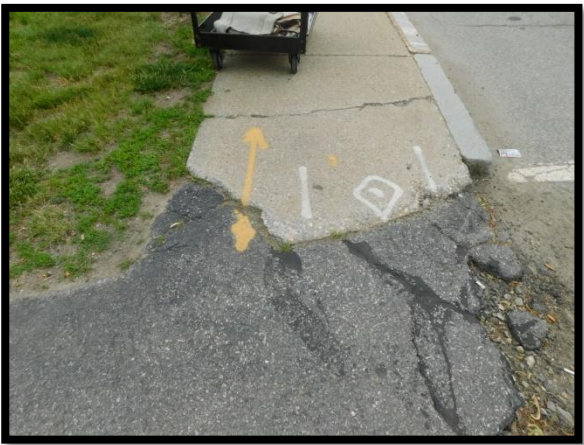
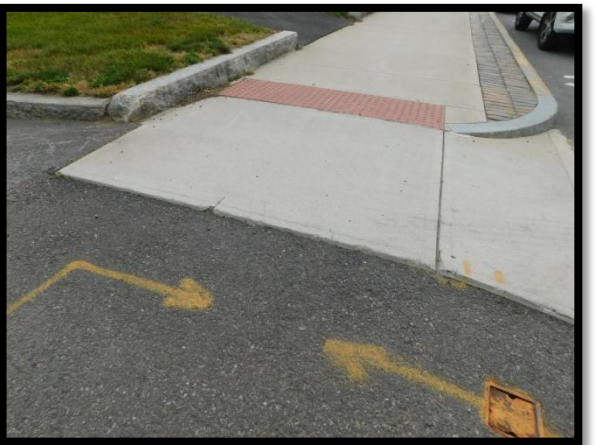
- The sidewalk at #133 is missing a concrete pad and has an abrupt change in level surface of 1"+.
- The sidewalk at #133 - #131 has a concrete pad that is heaving and abrupt changes in level surface of up to 2".

- There is a missing utility cover near #127 driveway. There is up to a 2" abrupt change in level surface at the #127 driveway/sidewalk.
- The sidewalk at Millbury Liquors has cross slopes up to 3.8%.

- There is sidewalk deterioration at #119, #121, #109, #103, #99, #97, at Puffin's driveway, and in front of Puffin's including abrupt changes in level surface of ½" to 2" and heaving. Sunken concrete at Puffin's driveway/sidewalk have cross slopes of up to 6.2%.

- There is severe concrete sidewalk deterioration across from Highland Street, at #75R, #75L, past #75, and past #73B. In addition there are also abrupt changes in level surface of up to 2".

- The sidewalk clear width at the Mulhane Funeral driveway is reduced to 15" as a result of deteriorated concrete and granite curbing. There is also a 1" abrupt change in level surface.
- The sidewalk – driveway transition at Sunrise Detox has a 1" gap and a 1" abrupt change in level surface.
- There is a 1" abrupt change in level surface at the asphalt sidewalk and concrete sidewalk transition at Farnsworth Court on the Millbury Baptist Church side.

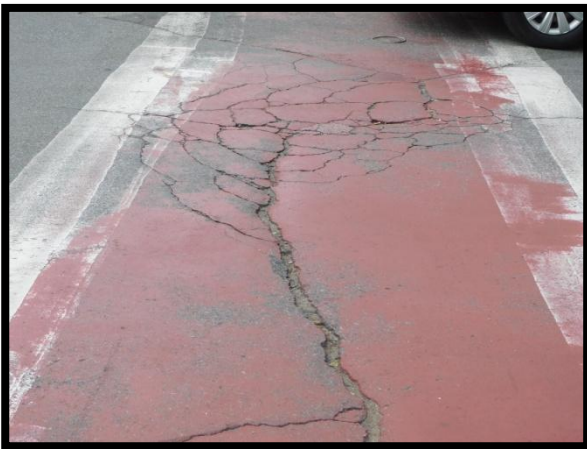
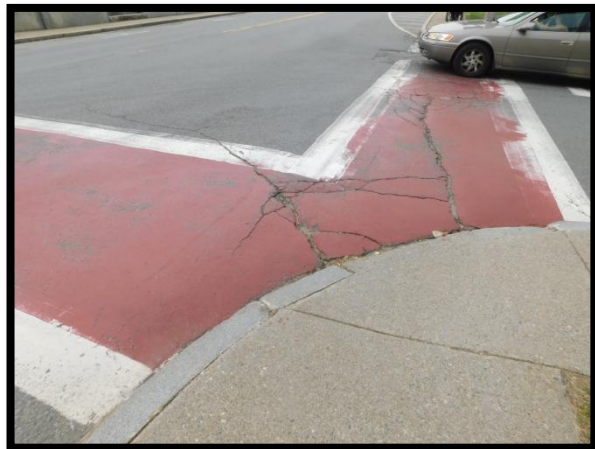
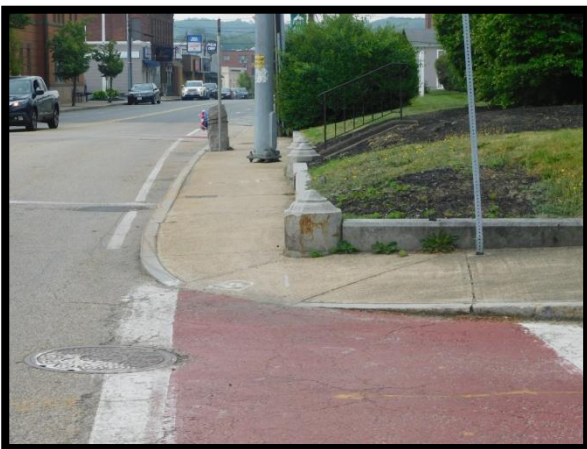
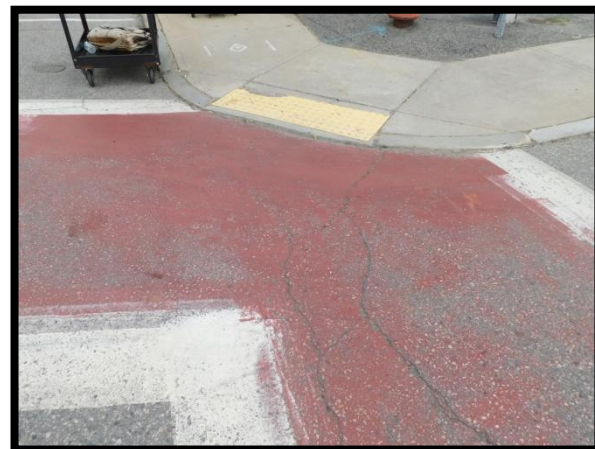
- The crosswalk across Main Street at Hamilton Street has curb ramps that lack detectable warning strips, lack level landings, and have up to 22.8% running slopes.

- The crosswalk across West Street has curb ramps that lack detectable warning strips, lack level landings, have 1" to 4" abrupt changes in level surface, and 12% to 21% running slopes. The crosswalk is severely deteriorated with cracking and gaps. The curb ramp at Saint Brigid's Church directing pedestrians across Main and West Streets is an apex curb ramp.

- The crosswalk across Main Street at Canal Street has curb ramps that lack detectable warning strips, lack level landings, and have up to 2" abrupt changes in level surface.

- The crosswalk across Grove Street has curb ramps with up to a 1" abrupt change in level surface at the Sunrise Detox side and is an apex curb ramp on the Walgreen's side.

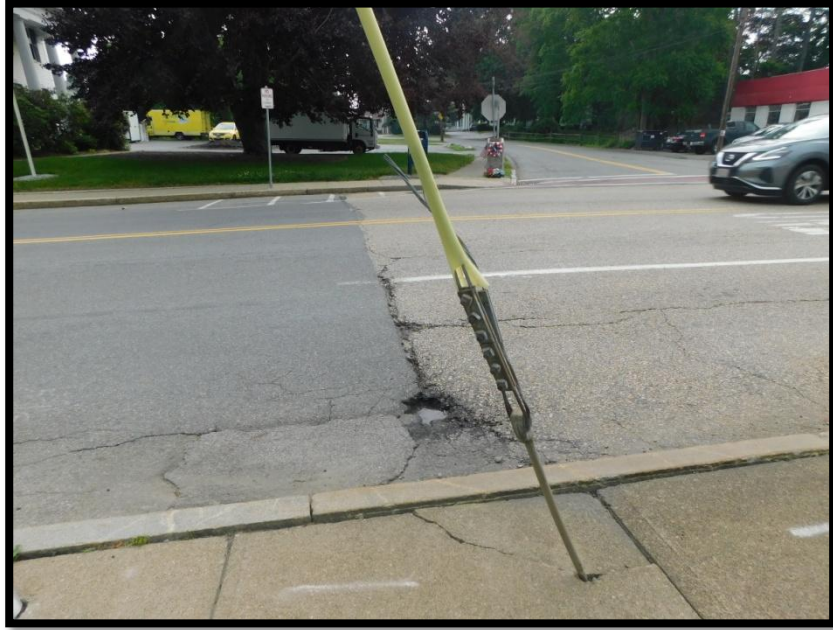
- Telephone pole #10 at Mulhanes Funeral Home has a guy wire which restricts head clearance and is a protruding object.
