City/State: Millbury, MA
Engineer: Alpha Omega Engineering (AOE)
Project: 44 Davis Road Site Plan (No. 17941041)

Site Inspection Report

Date: Wednesday, December 29, 2021
Weather: 30s°, Cloudy

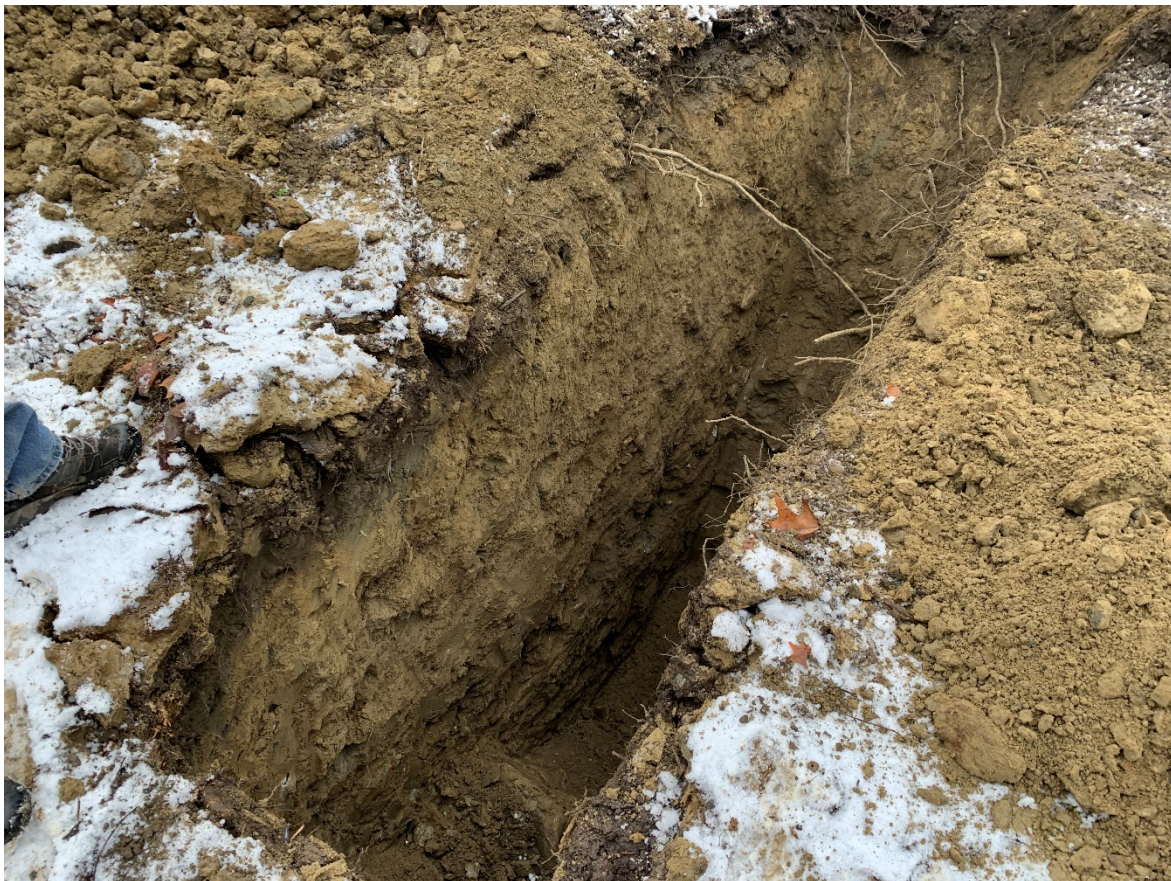
TEST PIT NO.1

- Excavated a 3-foot width by 8-foot length observation pit.
- No groundwater was observed at 108 inches (bottom of excavation)
- Estimated seasonal high ground water was observed by mottling at 60-inches
- Project engineer agreed to provide test pit log information to Town and Stantec.
- Test pit was backfilled after completed

Estimated seasonal high groundwater observed by mottling at 60-inches

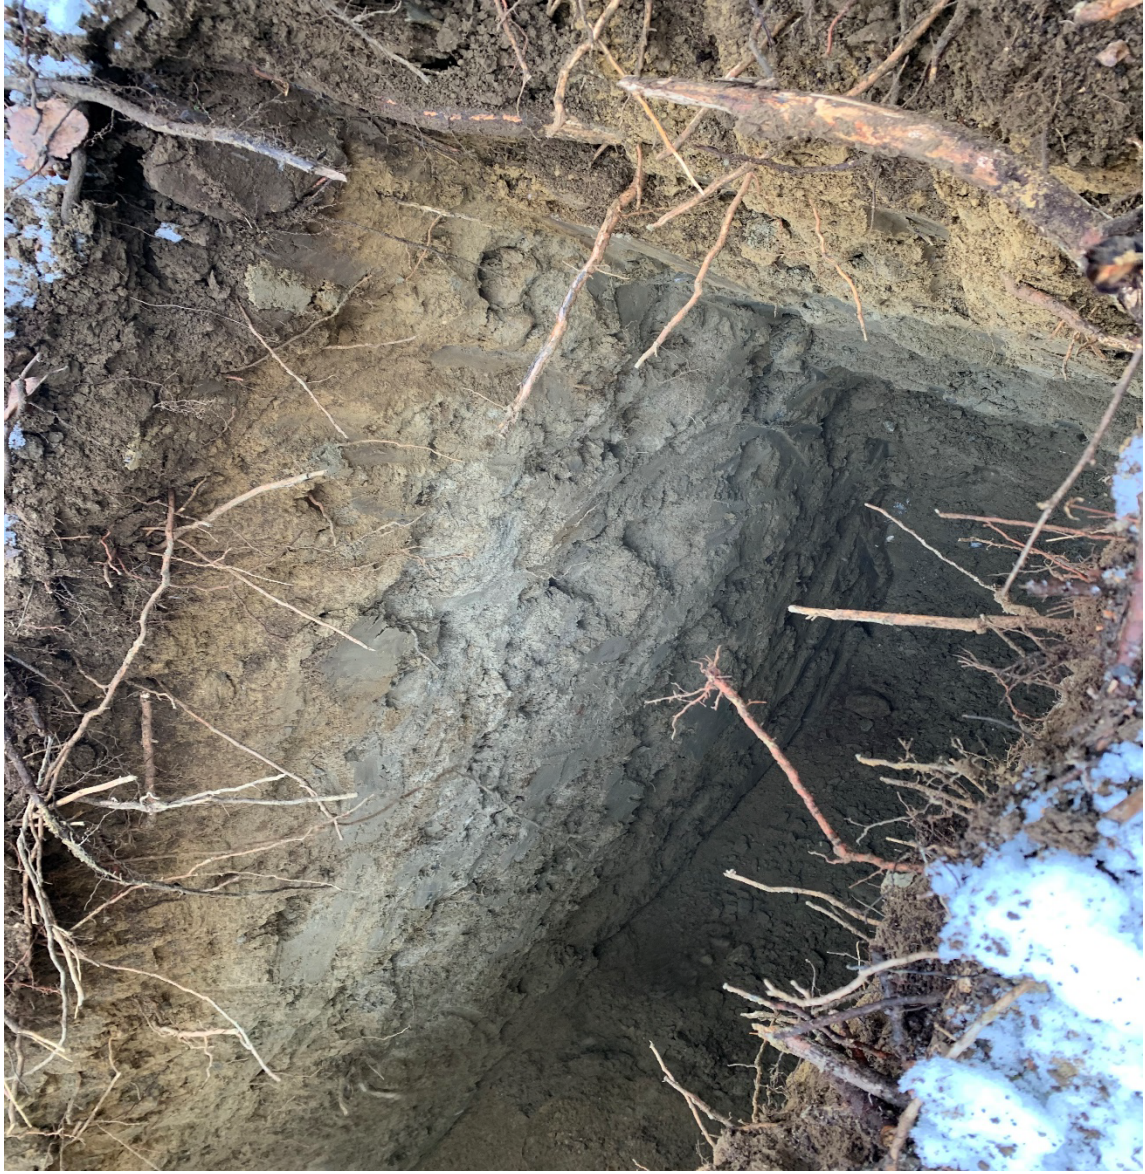
TEST PIT NO.2

- Excavated a 3-foot width by 9-foot length observation pit.
- No groundwater or mottling was observed at 96 inches (bottom of excavation)
- Project engineer agreed to provide test pit log information to Town and Stantec.
- Test pit was backfilled after completed

No groundwater or mottling was observed at 96-inches
